DRAINAGE SUB-BASIN ANALYSIS

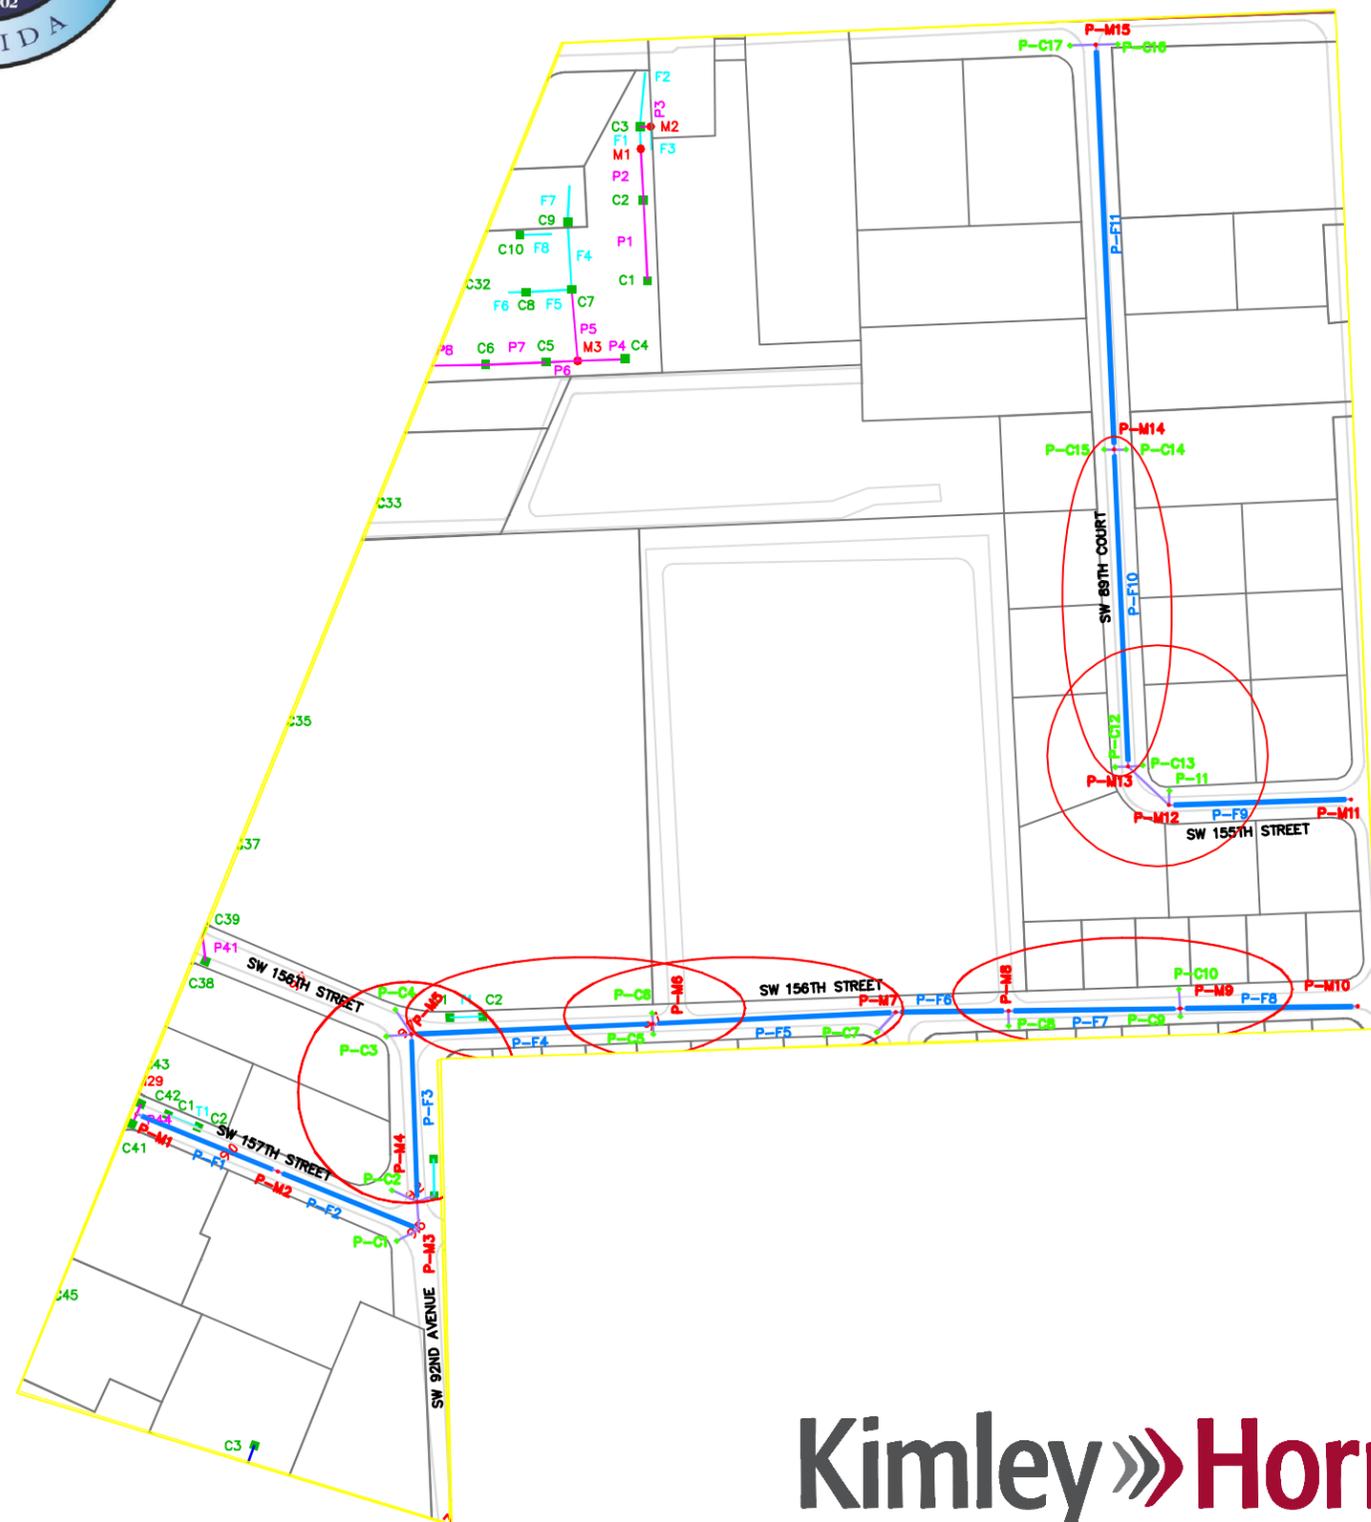
FIGURE 6: DRAINAGE SUB-BASIN #11 PROPOSED CONDITIONS

The flood stages shown for drainage sub-basin 11 exceed allowable levels and the sub-basin does not meet the performance goal criteria.

Storm Drainage Deficiencies: The catch basins inspected in this sub-basin were observed to be clean, with only limited debris and sediment. As a result, drainage deficiency issues are likely to be a function of limited system capacity and infrastructure age and or condition. Hydrologic and hydraulic calculations for this sub-basin confirmed the existing drainage infrastructure does not discharge adequate runoff to meet the desired performance criteria. The capacity of the existing swales and French drains is not sufficient to discharge the volume of runoff outlined in the performance criteria during the modeled storm events. Pavement condition within the sub-basin area is generally average and in need of resurfacing or rehabilitation. Improvements to drainage infrastructure will be needed to address these inadequacies.

Recommended Drainage Improvements: Clean and flush all sediment and debris from existing catch basins and pipes and adjust catch basin elevations and locations to minimize accumulation of sediment and debris. Install the additional infrastructure depicted in Figure 6. Existing catch basins should be modified or reconstructed as required to provide sediment traps (sumps) and pollution retardant baffles to protect the exfiltration trench. Constructing additional catch basins, manholes, culverts, and exfiltration trench is recommended to interconnect the catch basins.

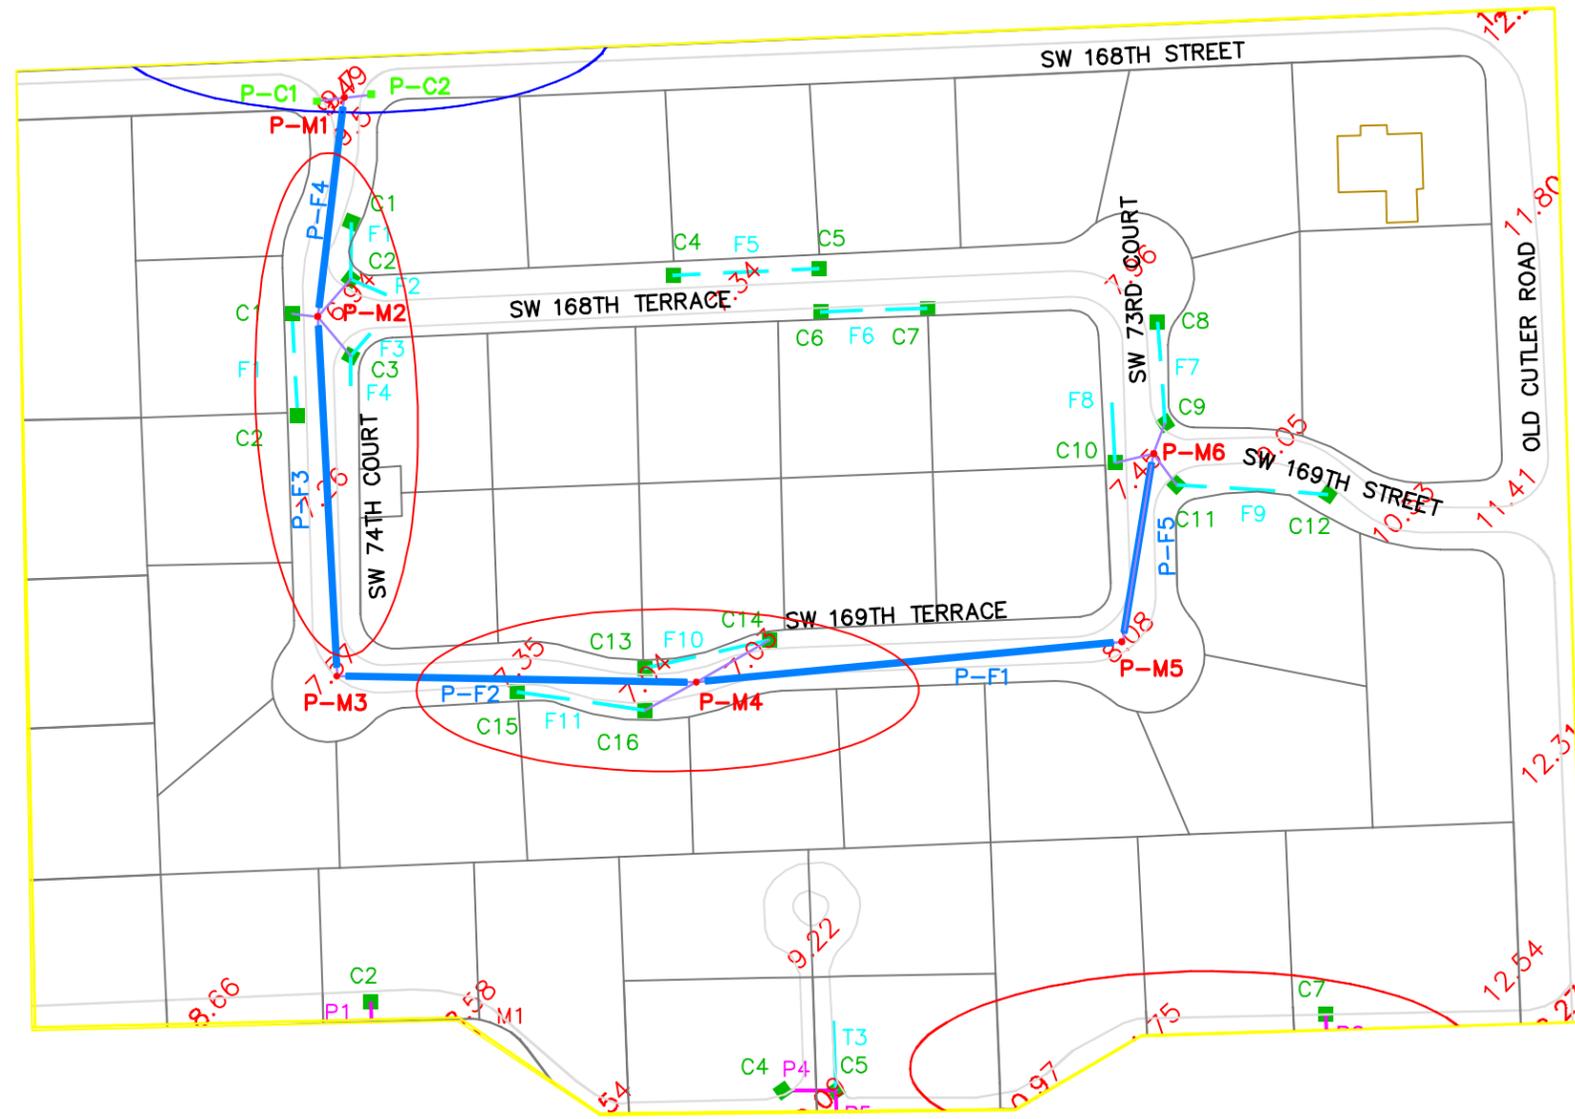
FIGURE 7: DRAINAGE SUB-BASIN #12 PROPOSED CONDITIONS

The flood stages shown above for drainage sub-basin 12 exceed allowable levels and the sub-basin does not meet the performance goal criteria.

Storm Drainage Deficiencies: The catch basins inspected in this sub-basin were observed to be clean, with only limited debris and sediment. As a result, drainage deficiency issues are likely to be a function of limited system capacity and infrastructure age and or condition. Hydrologic and hydraulic calculations for this sub-basin confirmed the existing drainage infrastructure does not discharge adequate runoff to meet the desired performance criteria. The capacity of the existing swales and French drains is not sufficient to discharge the volume of runoff outlined in the performance criteria during the modeled storm events. Pavement condition within the sub-basin area is generally in good condition, but would benefit from resurfacing. Improvements to drainage infrastructure will be needed to address these inadequacies.

Recommended Drainage Improvements: Clean and flush all sediment and debris from existing catch basins and pipes and adjust catch basin elevations and locations to minimize accumulation of sediment and debris. Install the additional infrastructure depicted in Figure 7. Existing catch basins should be modified or reconstructed as required to provide sediment traps (sumps) and pollution retardant baffles to protect the exfiltration trench. Constructing additional catch basins, manholes, culverts, and exfiltration trench is recommended to interconnect the catch basins.

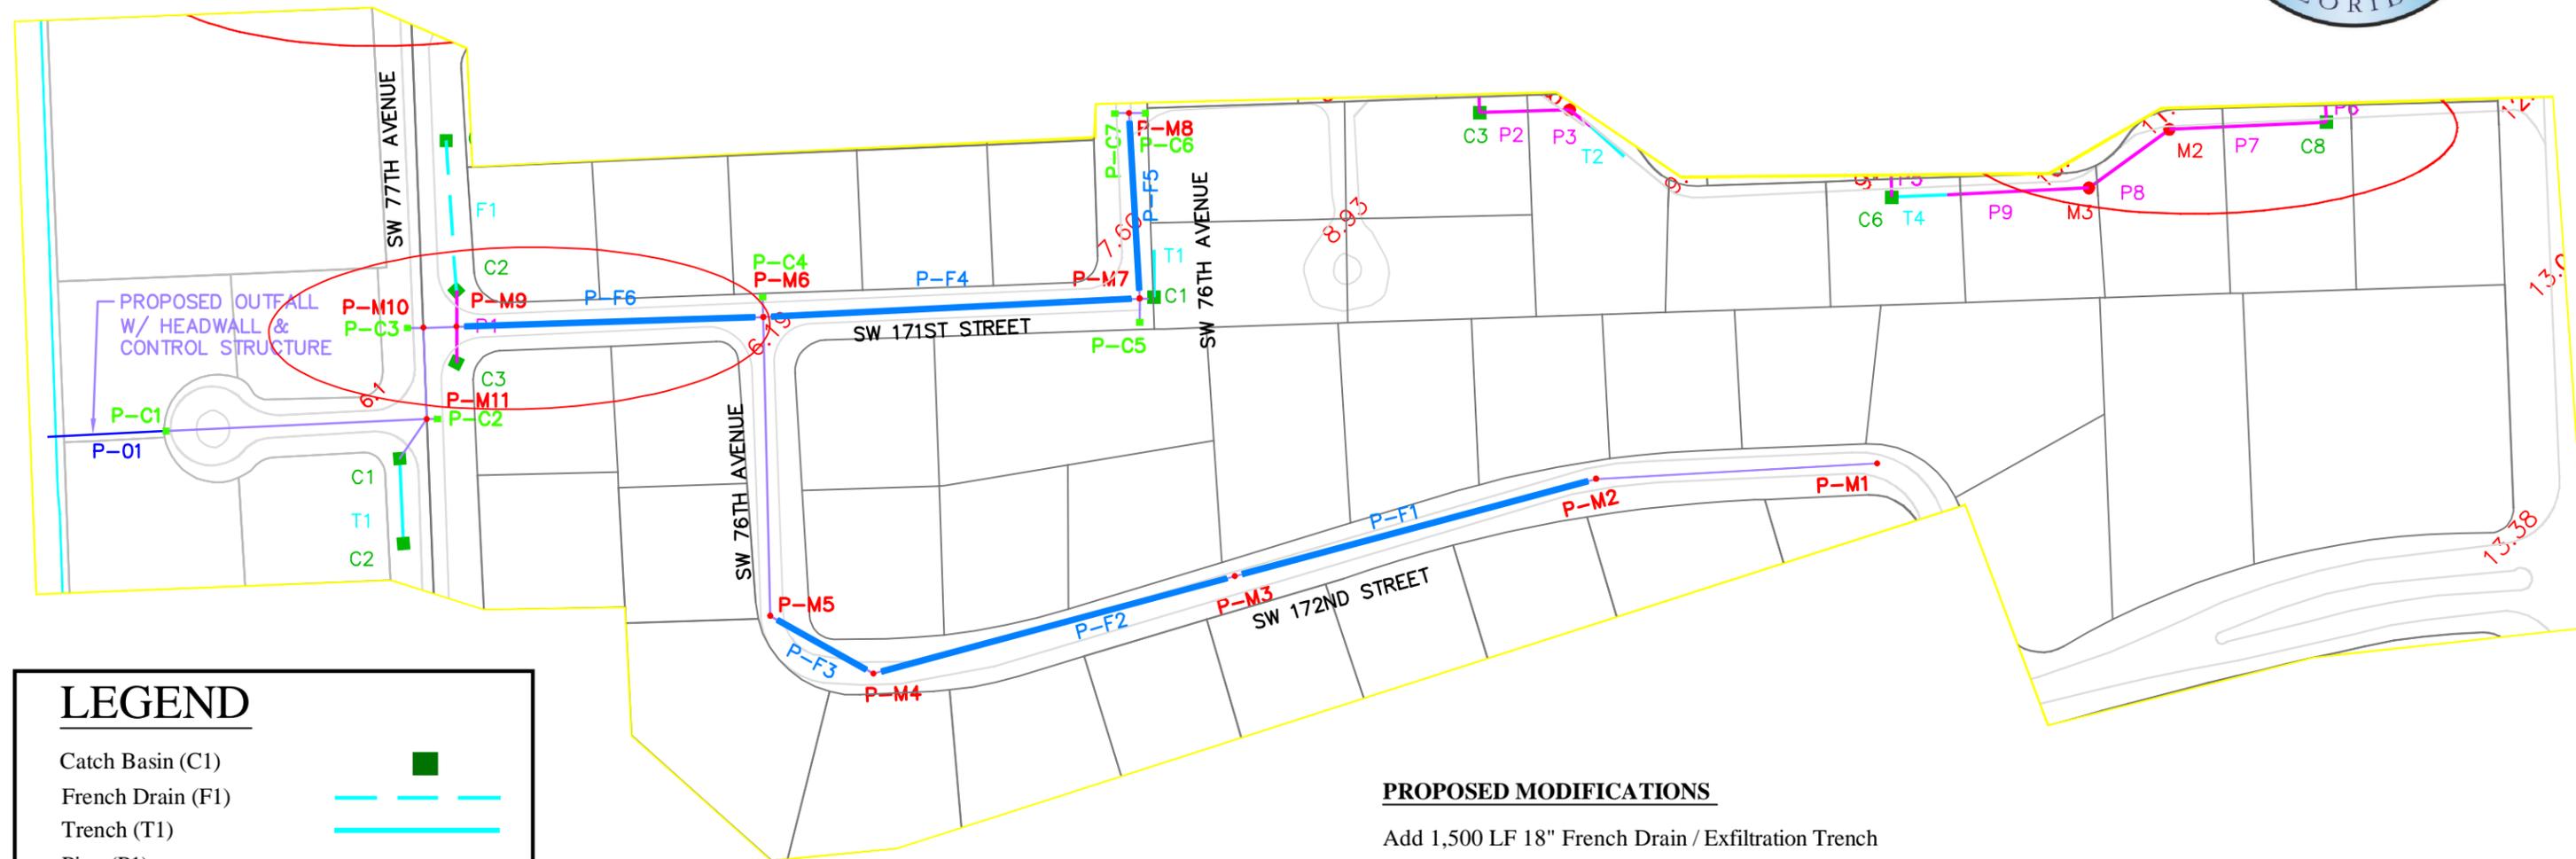
FIGURE 8: DRAINAGE SUB-BASIN #39 PROPOSED CONDITIONS

The flood stages shown above for drainage sub-basin 39 exceed allowable levels and the sub-basin does not meet the performance goal criteria.

Storm Drainage Deficiencies: The catch basins inspected in this sub-basin were observed to be clean, with only limited debris and sediment. As a result, drainage deficiency issues are likely to be a function of limited system capacity and infrastructure age and or condition. Hydrologic and hydraulic calculations for this sub-basin confirmed the existing drainage infrastructure does not discharge adequate runoff to meet the desired performance criteria. The capacity of the existing swales and French drains is not sufficient to discharge the volume of runoff outlined in the performance criteria during the modeled storm events. Pavement condition within the sub-basin area is generally in good condition, but would benefit from resurfacing. Roadway settlement at the intersection of SW 171st Street and SW 77th Avenue was observed. Improvements to drainage infrastructure will be needed to address these inadequacies. SW 171st Street is a cul-de-sac with an opportunity to install an outfall connection. No existing outfall was observed.

Recommended Drainage Improvements: Clean and flush all sediment and debris from existing catch basins and pipes and adjust catch basin elevations and locations to minimize accumulation of sediment and debris. Install the additional infrastructure depicted in Figure 8. Existing catch basins should be modified or reconstructed as required to provide sediment traps (sumps) and pollution retardant baffles to protect the exfiltration trench. Constructing additional catch basins, manholes, culverts, and exfiltration trench is recommended to interconnect the catch basins. This sub-basin has the possibility of a new outfall connection as well.

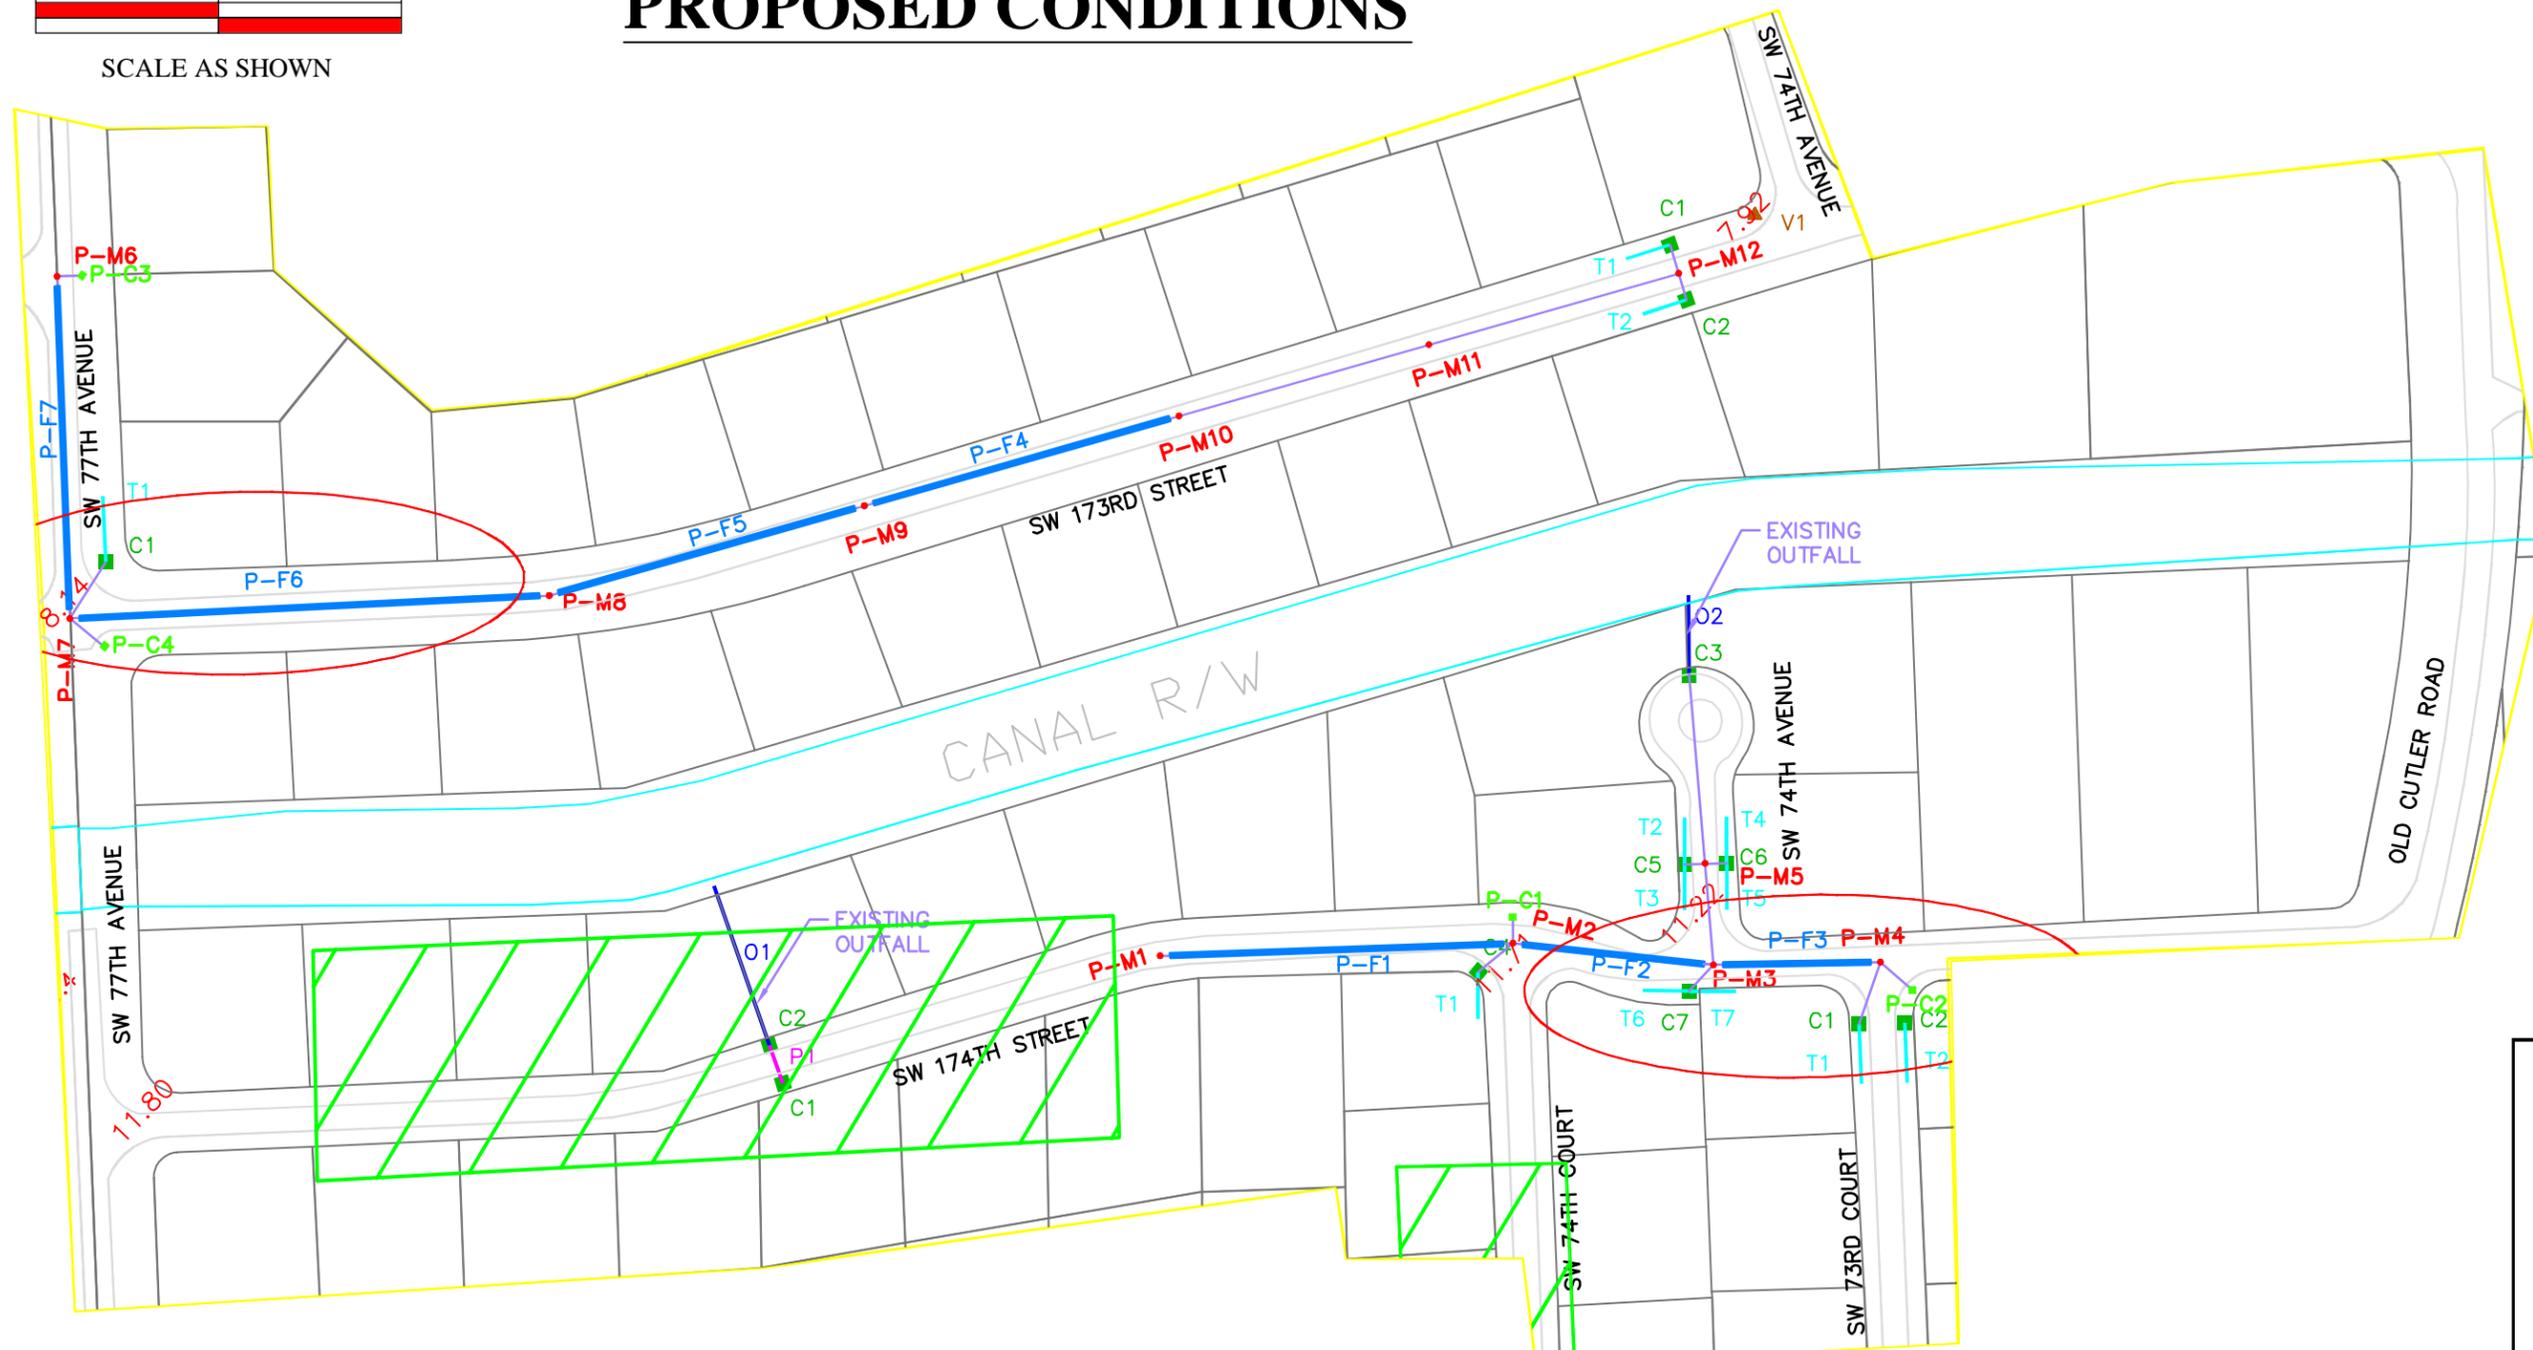
FIGURE 9: DRAINAGE SUB-BASIN #41 PROPOSED CONDITIONS

The flood stages shown above for drainage sub-basin 41 exceed allowable levels and the sub-basin does not meet the performance goal criteria.

Storm Drainage Deficiencies: The catch basins inspected in this sub-basin were observed to be clean, with only limited debris and sediment. As a result, drainage deficiency issues are likely to be a function of limited system capacity and infrastructure age and or condition. Hydrologic and hydraulic calculations for this sub-basin confirmed the existing drainage infrastructure does not discharge adequate runoff to meet the desired performance criteria. The capacity of the existing swales, outfalls, and French drains is not sufficient to discharge the volume of runoff outlined in the performance criteria during the modeled storm events. Pavement condition within the sub-basin area is generally in good condition, but would benefit from resurfacing. Improvements to drainage infrastructure will be needed to address these inadequacies. SW 77th Court is a cul-de-sac just west of the sub-basin 41 limits, but may provide an opportunity to install an outfall connection if needed. No existing outfall was observed.

Recommended Drainage Improvements: Clean and flush all sediment and debris from existing catch basins, pipes, outfalls, and adjust catch basin elevations and locations to minimize accumulation of sediment and debris. Install the additional infrastructure depicted in Figure 9. Existing catch basins should be modified or reconstructed as required to provide sediment traps (sumps) and pollution retardant baffles to protect the exfiltration trench. An analysis of the existing outfall capacities should be performed to evaluate the need for potential outfall improvements as well as the benefits of an additional outfall on SW 77th Court. Constructing additional catch basins, manholes, culverts, and exfiltration trench is recommended to interconnect the catch basins.

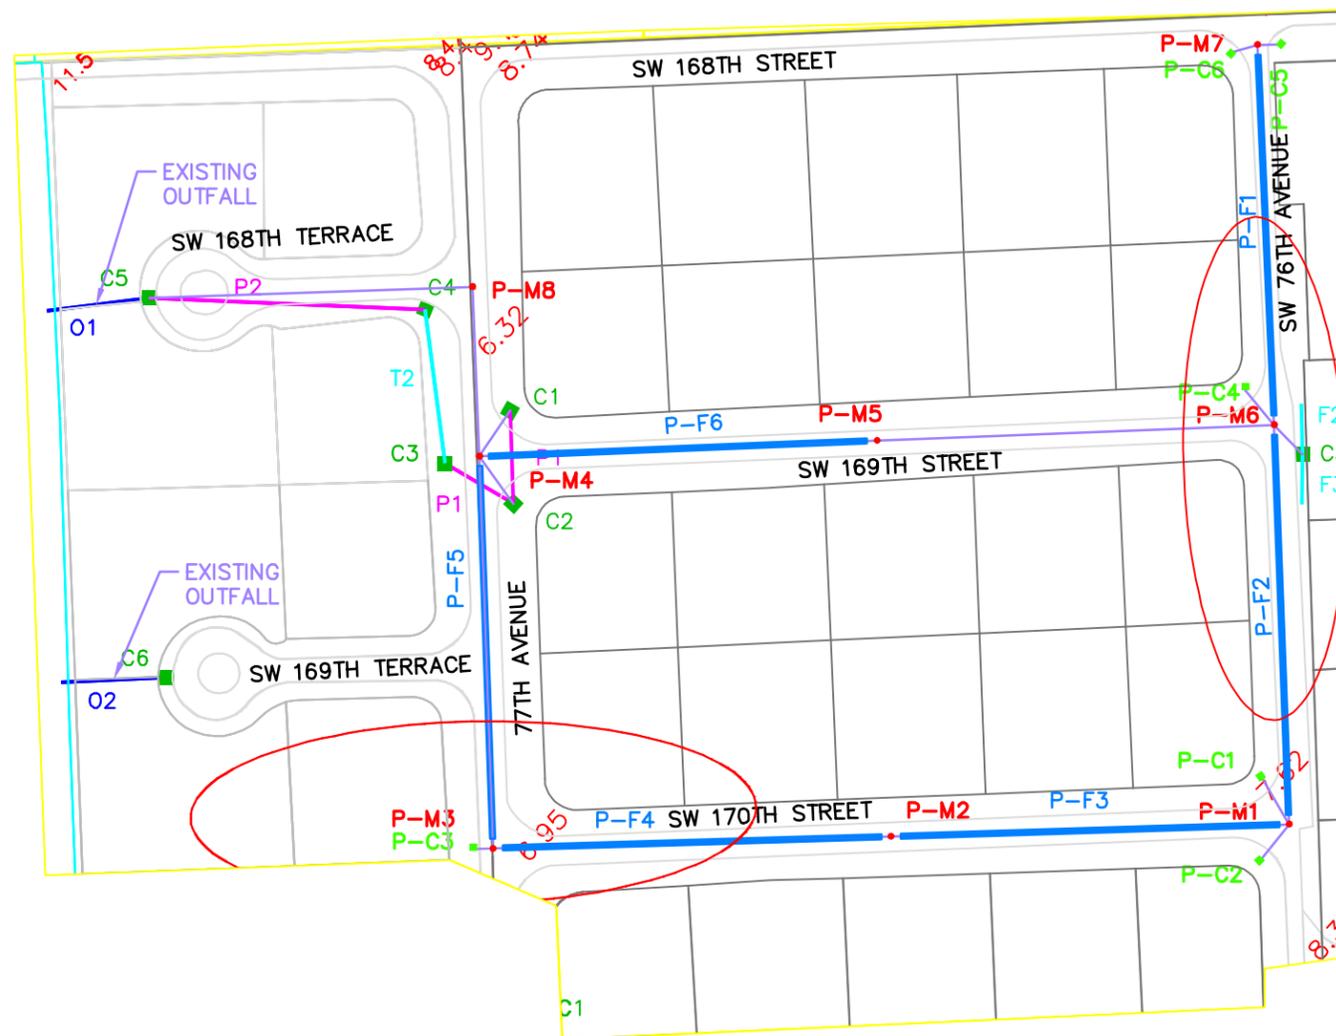
FIGURE 10: DRAINAGE SUB-BASIN #42 PROPOSED CONDITIONS

Storm Drainage Deficiencies: The catch basins inspected in this sub-basin were observed to be clean, with only limited debris and sediment. As a result, drainage deficiency issues are likely to be a function of limited system capacity and infrastructure age and or condition. Hydrologic and hydraulic calculations for this sub-basin confirmed the existing drainage infrastructure does not discharge adequate runoff to meet the desired performance criteria. The capacity of the existing swales, outfalls, and French drains is not sufficient to discharge the volume of runoff outlined in the performance criteria during the modeled storm events. Pavement condition within the sub-basin area is generally average and in need of resurfacing or rehabilitation. Improvements to drainage infrastructure will be needed to address these inadequacies.

Recommended Drainage Improvements: Clean and flush all sediment and debris from existing catch basins, pipes, outfalls, and adjust catch basin elevations and locations to minimize accumulation of sediment and debris. Install the additional infrastructure depicted in Figure 10. Existing catch basins should be modified or reconstructed as required to provide sediment traps (sumps) and pollution retardant baffles to protect the exfiltration trench. An analysis of the existing outfall capacities should be performed to evaluate the need for potential outfall improvements. Constructing additional catch basins, manholes, culverts, and exfiltration trench is recommended to interconnect the catch basins.

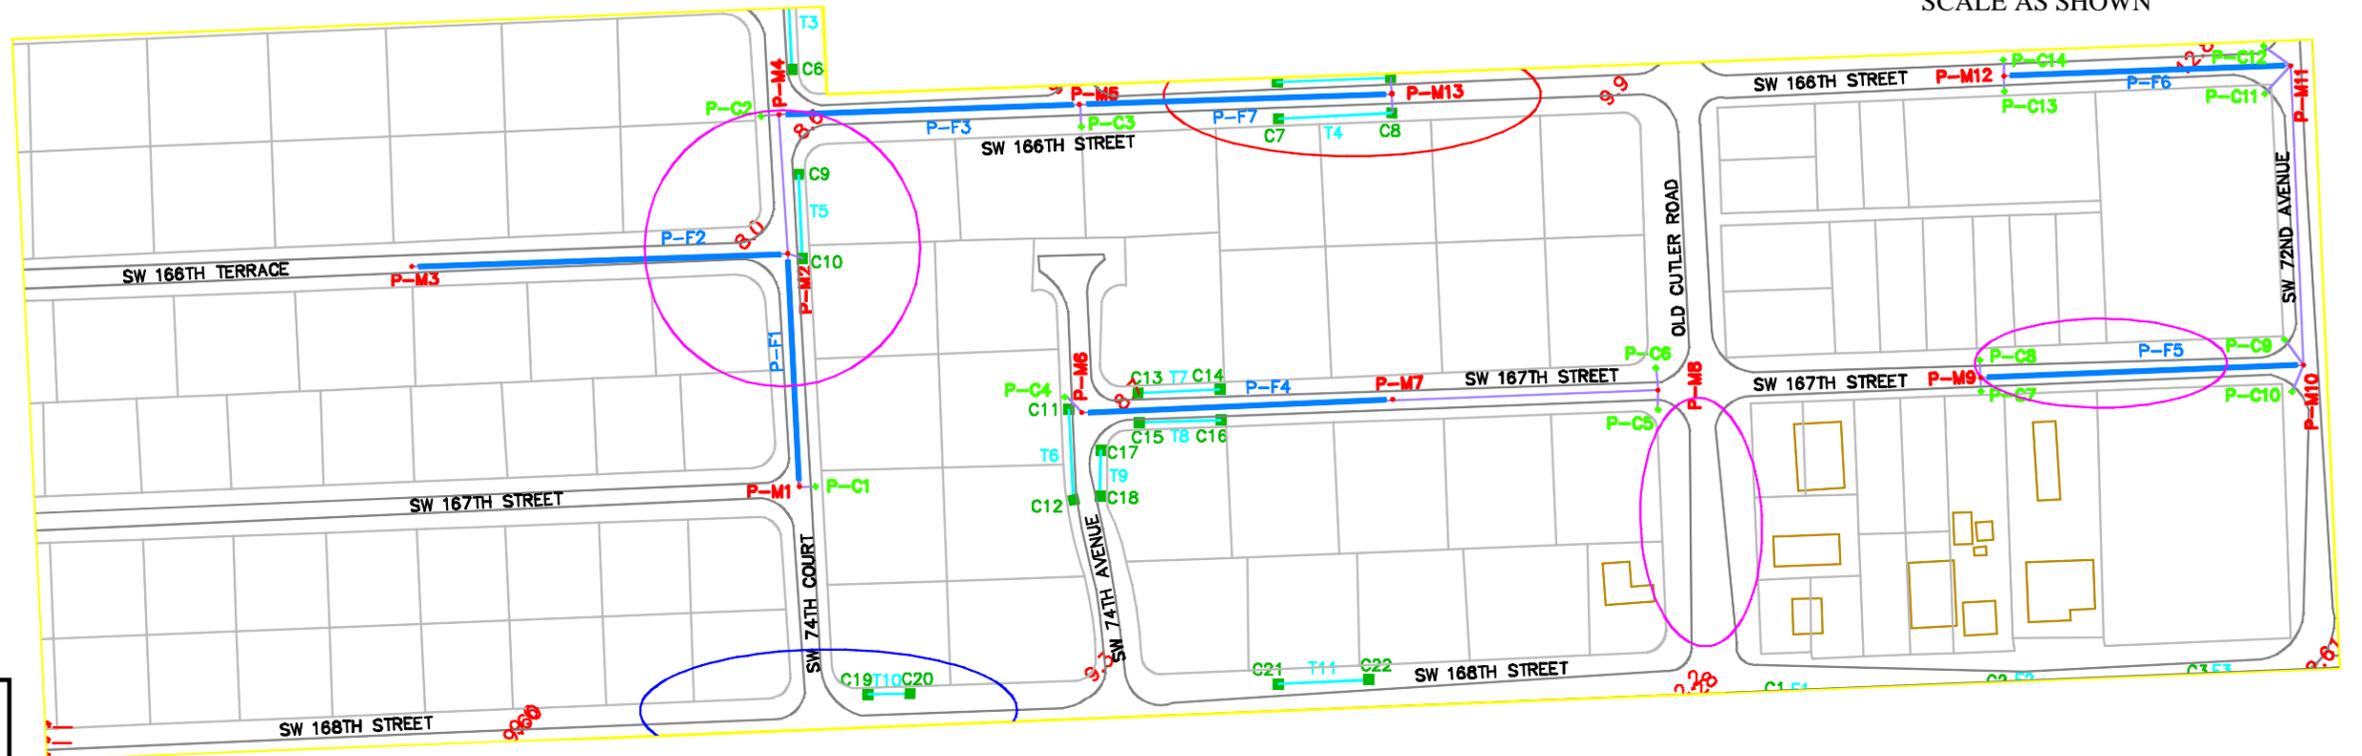
FIGURE 11: DRAINAGE SUB-BASIN #43 PROPOSED CONDITIONS

Complaints were reported in this area by the Village at SW 167th Street and on Old Cutler Road. Complaints from Miami-Dade County were identified in drainage sub-basin 43 as part of the original master plan. In our investigation, Kimley-Horn found flooding extending across the entire roadway width on SW 166th Street, SW 166th Terrace and

SW 74th Court. The location of these deficiencies can be seen in Figure 11. The entire sub-basin area was modeled based on data collected as part of the Stormwater Master Plan process.

Storm Drainage Deficiencies: The catch basins inspected in this sub-basin were observed to be clean, with only limited debris and sediment. As a result, drainage deficiency issues are likely to be a function of limited system capacity and infrastructure age and or condition. Hydrologic and hydraulic calculations for this sub-basin confirmed the existing drainage infrastructure does not discharge adequate runoff to meet the desired performance criteria. The capacity of the existing swales and French drains is not sufficient to discharge the volume of runoff outlined in the performance criteria during the modeled storm events. Pavement condition within the sub-basin area is generally average and in need of resurfacing or rehabilitation. Improvements to drainage infrastructure will be needed to address these inadequacies.

Recommended Drainage Improvements: Clean and flush all sediment and debris from existing catch basins and pipes and adjust catch basin elevations and locations to minimize accumulation of sediment and debris. Install the additional infrastructure depicted in Figure 11. Existing catch basins should be modified or reconstructed as required to provide sediment traps (sumps) and pollution retardant baffles to protect the exfiltration trench. Constructing additional catch basins, manholes, culverts, and exfiltration trench is recommended to interconnect the catch basins.

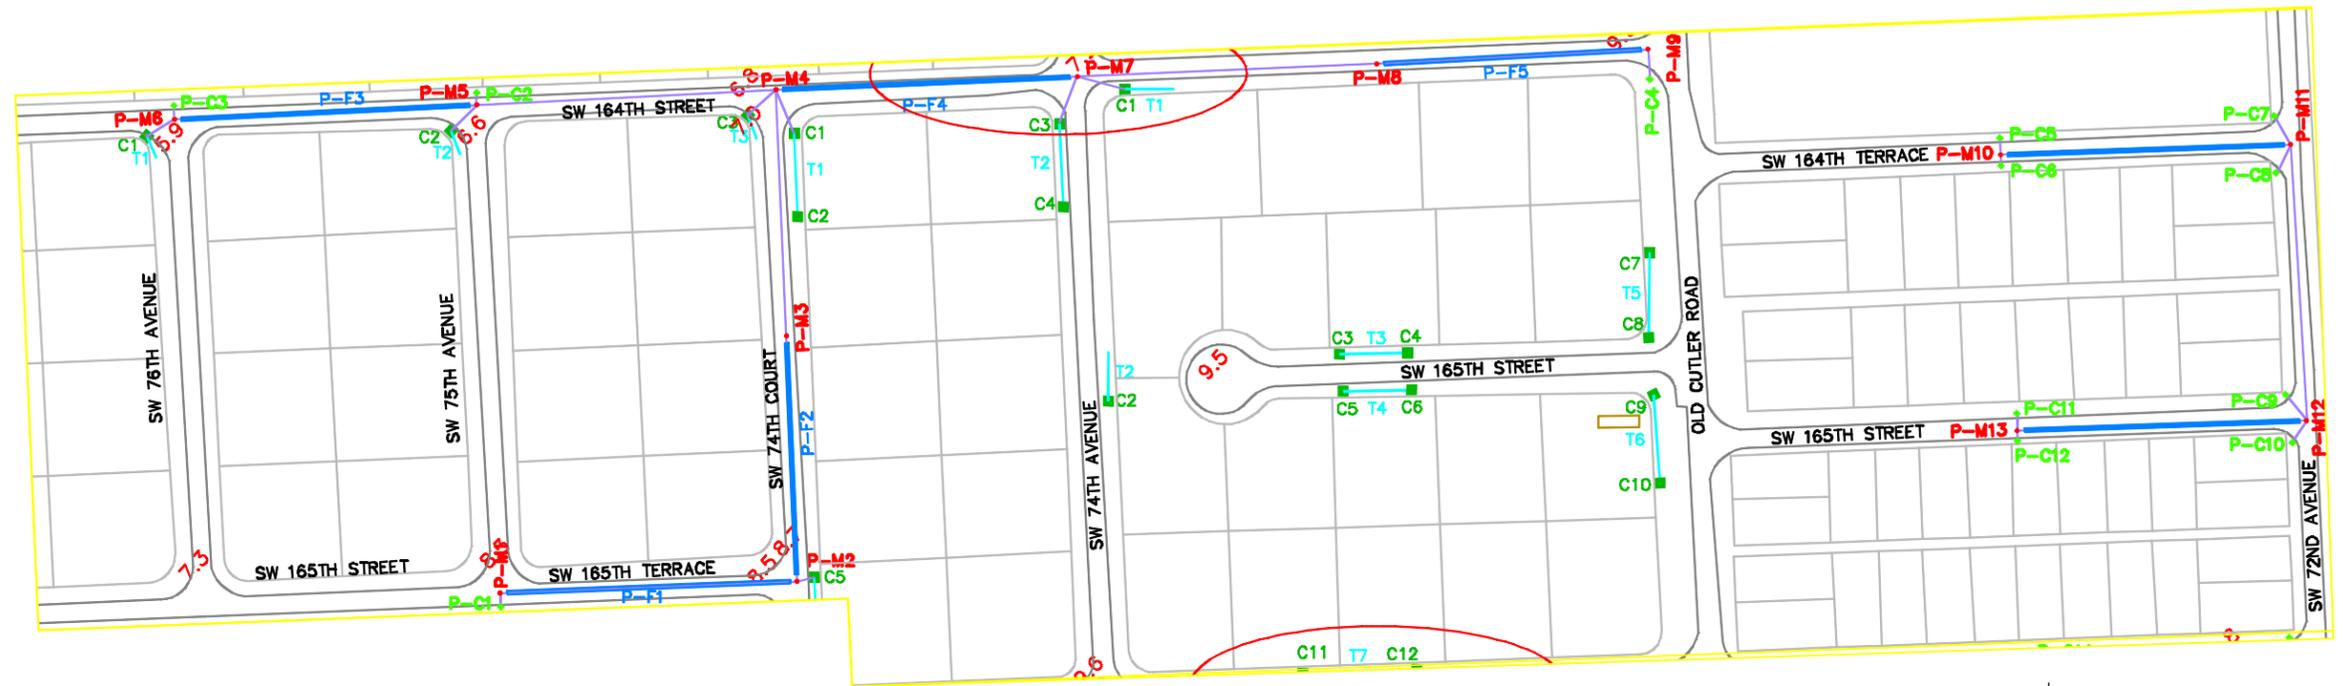
FIGURE 12: DRAINAGE SUB-BASIN #44 PROPOSED CONDITIONS

Storm Drainage Deficiencies: The catch basins inspected in this sub-basin were observed to be clean, with only limited debris and sediment. As a result, drainage deficiency issues are likely to be a function of limited system capacity and infrastructure age and or condition. Hydrologic and hydraulic calculations for this sub-basin confirmed the existing drainage infrastructure does not discharge adequate runoff to meet the desired performance criteria. The capacity of the existing swales and French drains is not sufficient to discharge the volume of runoff outlined in the performance criteria during the modeled storm events. Pavement condition within the sub-basin area is generally in good condition, but would benefit from resurfacing. Improvements to drainage infrastructure will be needed to address these inadequacies.

Recommended Drainage Improvements: Clean and flush all sediment and debris from existing catch basins and pipes and adjust catch basin elevations and locations to minimize accumulation of sediment and debris. Install the additional infrastructure depicted in Figure 12. Existing catch basins should be modified or reconstructed as required to provide sediment traps (sumps) and pollution retardant baffles to protect the exfiltration trench. Constructing additional catch basins, manholes, culverts, and exfiltration trench is recommended to interconnect the catch basins.

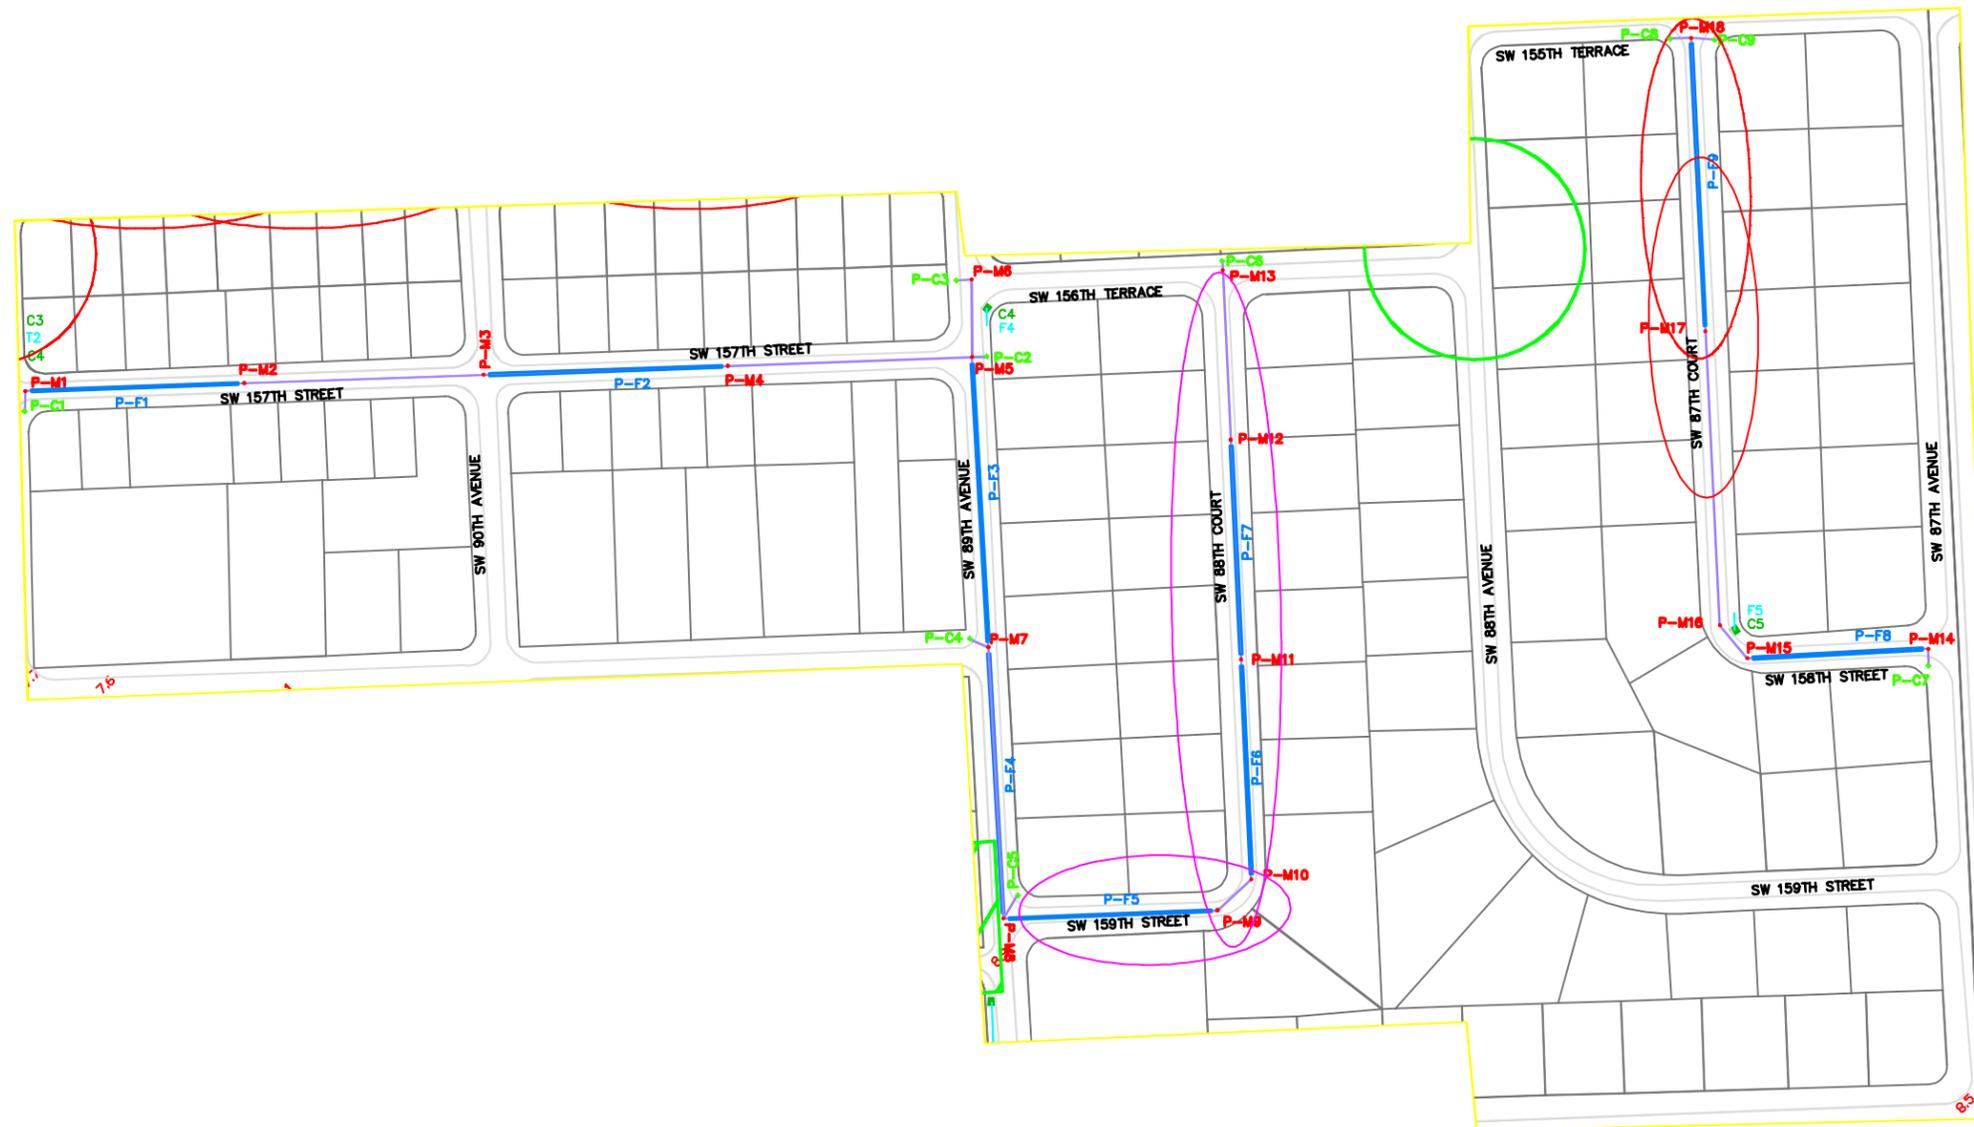
FIGURE 13: DRAINAGE SUB-BASIN #57/96 PROPOSED CONDITIONS

The Village reported extensive flooding on SW 88th Court and SW 159th Street in drainage sub-basin 96. In our investigation, Kimley-Horn found flooding extending across the entire roadway width on SW 87th Court. The location of these deficiencies can be seen in Figure 13. The entire sub-basin area was modeled based on data collected as part of the Stormwater Master Plan process. The Village has a localized flooding project proposed at the intersection of SW 88th Avenue and SW 156th Terrace.

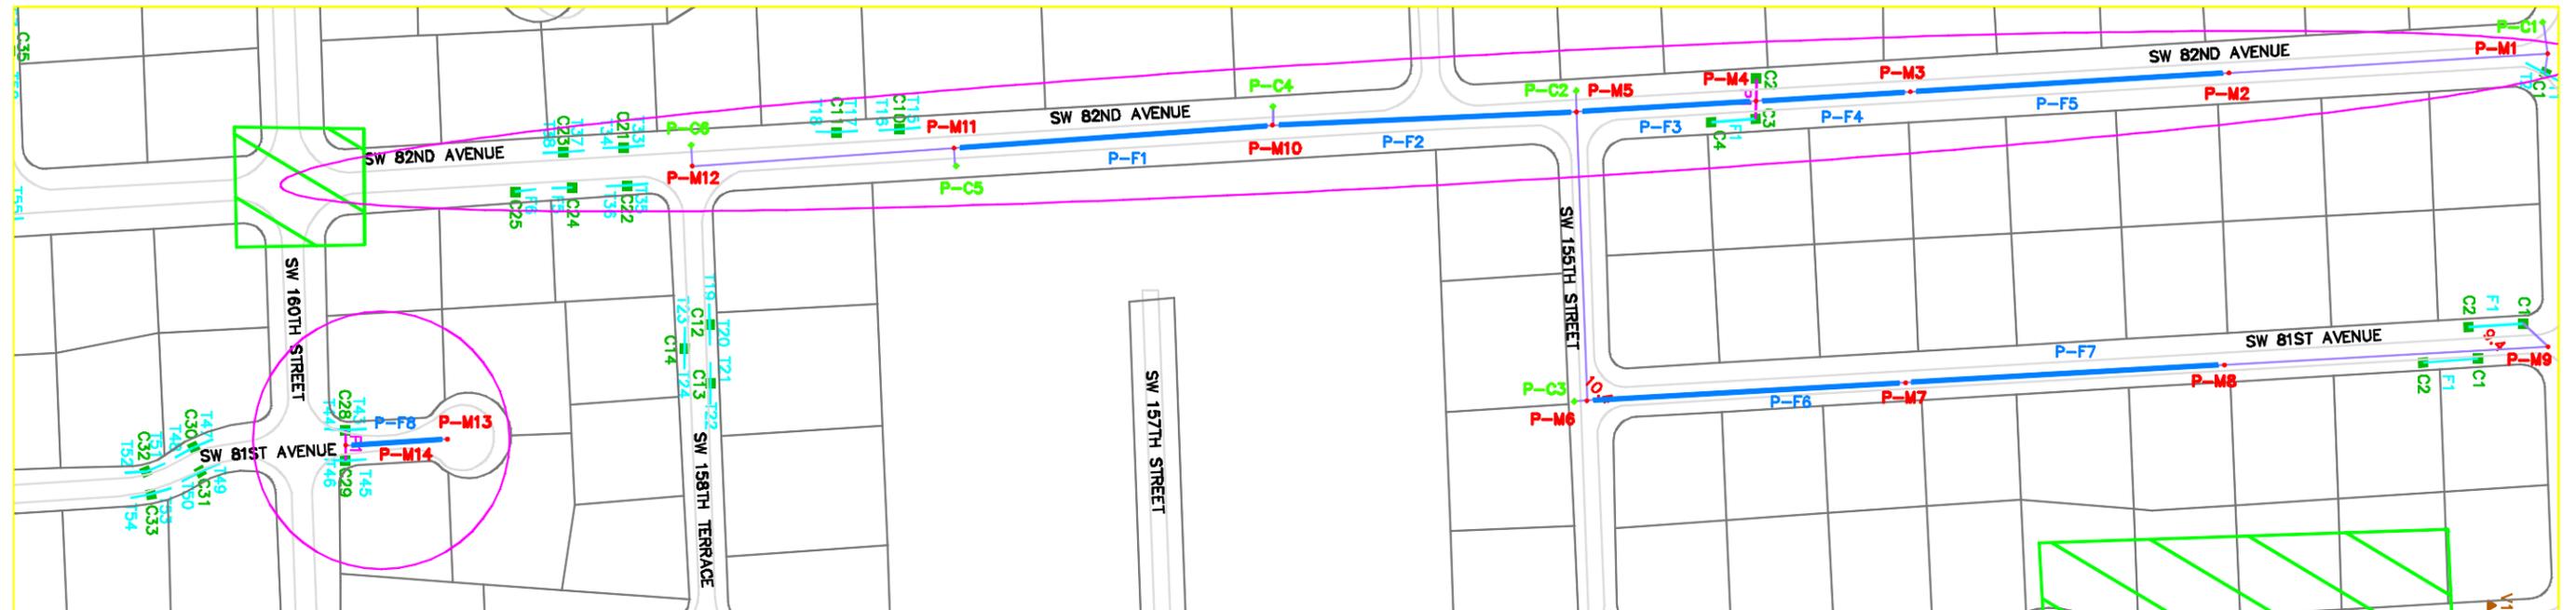
FIGURE 14: DRAINAGE SUB-BASIN #59/60 PROPOSED CONDITIONS

The Village of Palmetto Bay reported severe flooding complaints on SW 82nd Avenue and localized flooding on SW 160th Street west of SW 80th Avenue. The location of these deficiencies can be seen in Figure 14. The entire sub-basin area was modeled based on data collected as part of the Stormwater Master Plan process. The Village installed a traffic circle with localized drainage improvements at the intersection of SW 160th Street and SW 82nd Avenue, as well as a second localized drainage improvement on SW 80th Avenue just south of SW 152nd Street.

infrastructure does not discharge adequate runoff to meet the desired performance criteria. The capacity of the existing swales and French drains is not sufficient to discharge the volume of runoff outlined in the performance criteria during the modeled storm events. Pavement condition within the sub-basin area is generally average and in need of resurfacing or rehabilitation. Improvements to drainage infrastructure will be needed to address these inadequacies.
