DRAINAGE SUB-BASIN ANALYSIS

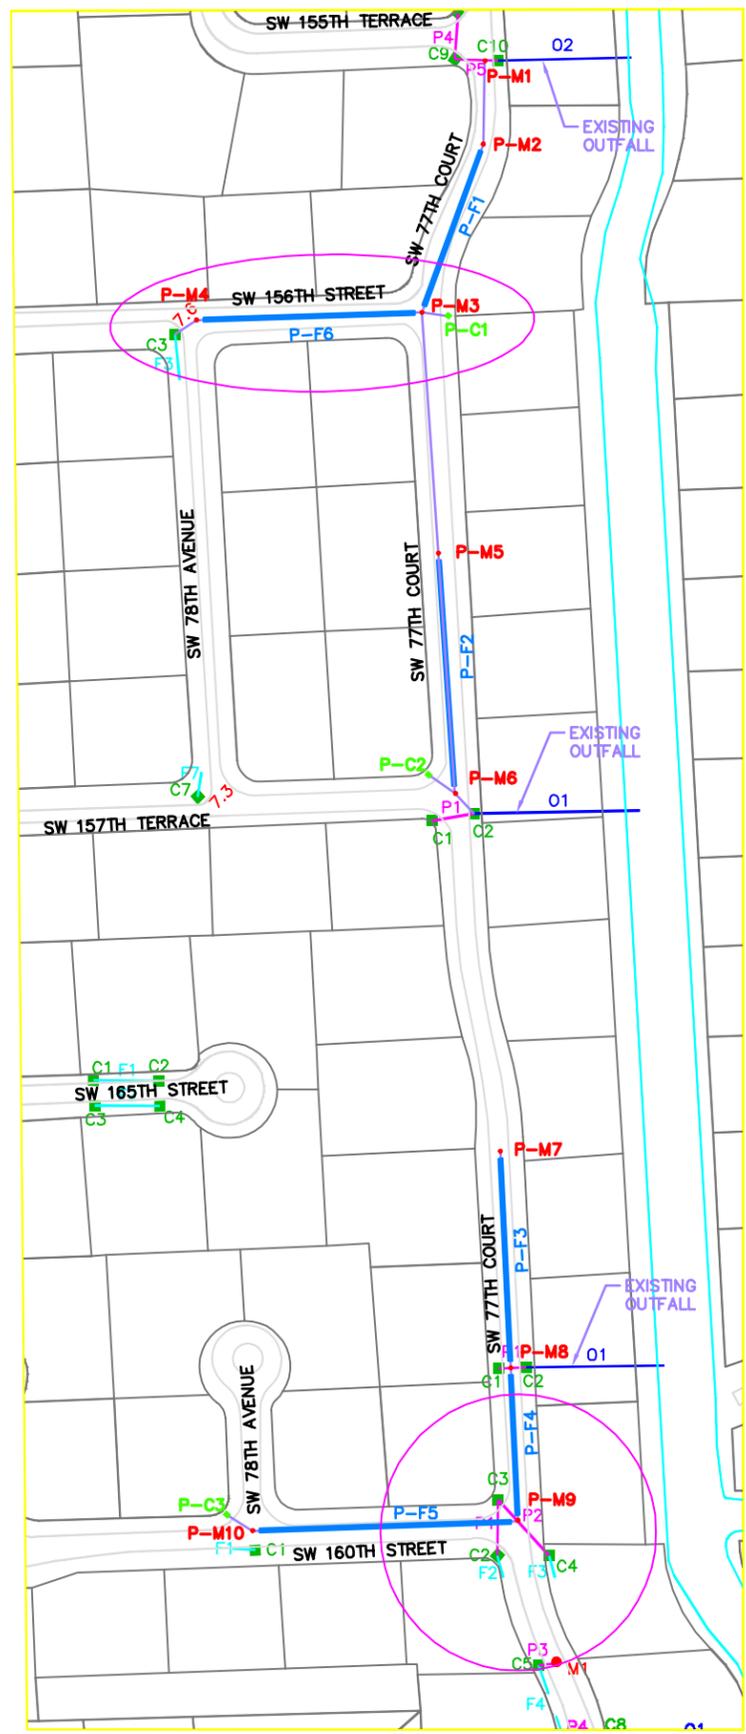
FIGURE 15: DRAINAGE SUB-BASIN #61 PROPOSED CONDITIONS

The Village of Palmetto Bay reported flooding complaints on SW 156th Street, SW 160th Street, and SW 77th Court. The location of these deficiencies can be seen in Figure 15. The entire sub-basin area was modeled based on data collected as part of the Stormwater Master Plan process.

Recommended Drainage Improvements: Clean and flush all sediment and debris from existing catch basins, pipes, outfalls, and adjust catch basin elevations and locations to minimize accumulation of sediment and debris. Install the additional infrastructure depicted in Figure 15. Existing catch basins should be modified or reconstructed as required to provide sediment traps (sumps) and pollution retardant baffles to protect the exfiltration trench. An analysis of the existing outfall capacities should be performed to evaluate the need for potential outfall improvements. Constructing additional catch basins, manholes, culverts, and exfiltration trench is recommended to interconnect the catch basins.
