**RESOLUTION NO. 2015-19**

**A RESOLUTION OF THE MAYOR AND VILLAGE COUNCIL OF THE VILLAGE OF PALMETTO BAY, FLORIDA; RELATING TO THE STORMWATER MASTER PLAN UPDATE REPORT, ACCEPTING THE FINAL REPORT DOCUMENTS AND RECOMMENDATIONS; FURTHER AUTHORIZING THE VILLAGE MANAGER TO PROCEED WITH IMPLEMENTATION OF THE REPORT FINDINGS, FOLLOWING IDENTIFICATION AND AVAILABILITY OF APPROPRIATE FUNDING SOURCES; AND PROVIDING FOR AN EFFECTIVE DATE.**

Prepared For  
Village of Palmetto Bay, Florida

# Stormwater Master Plan Update

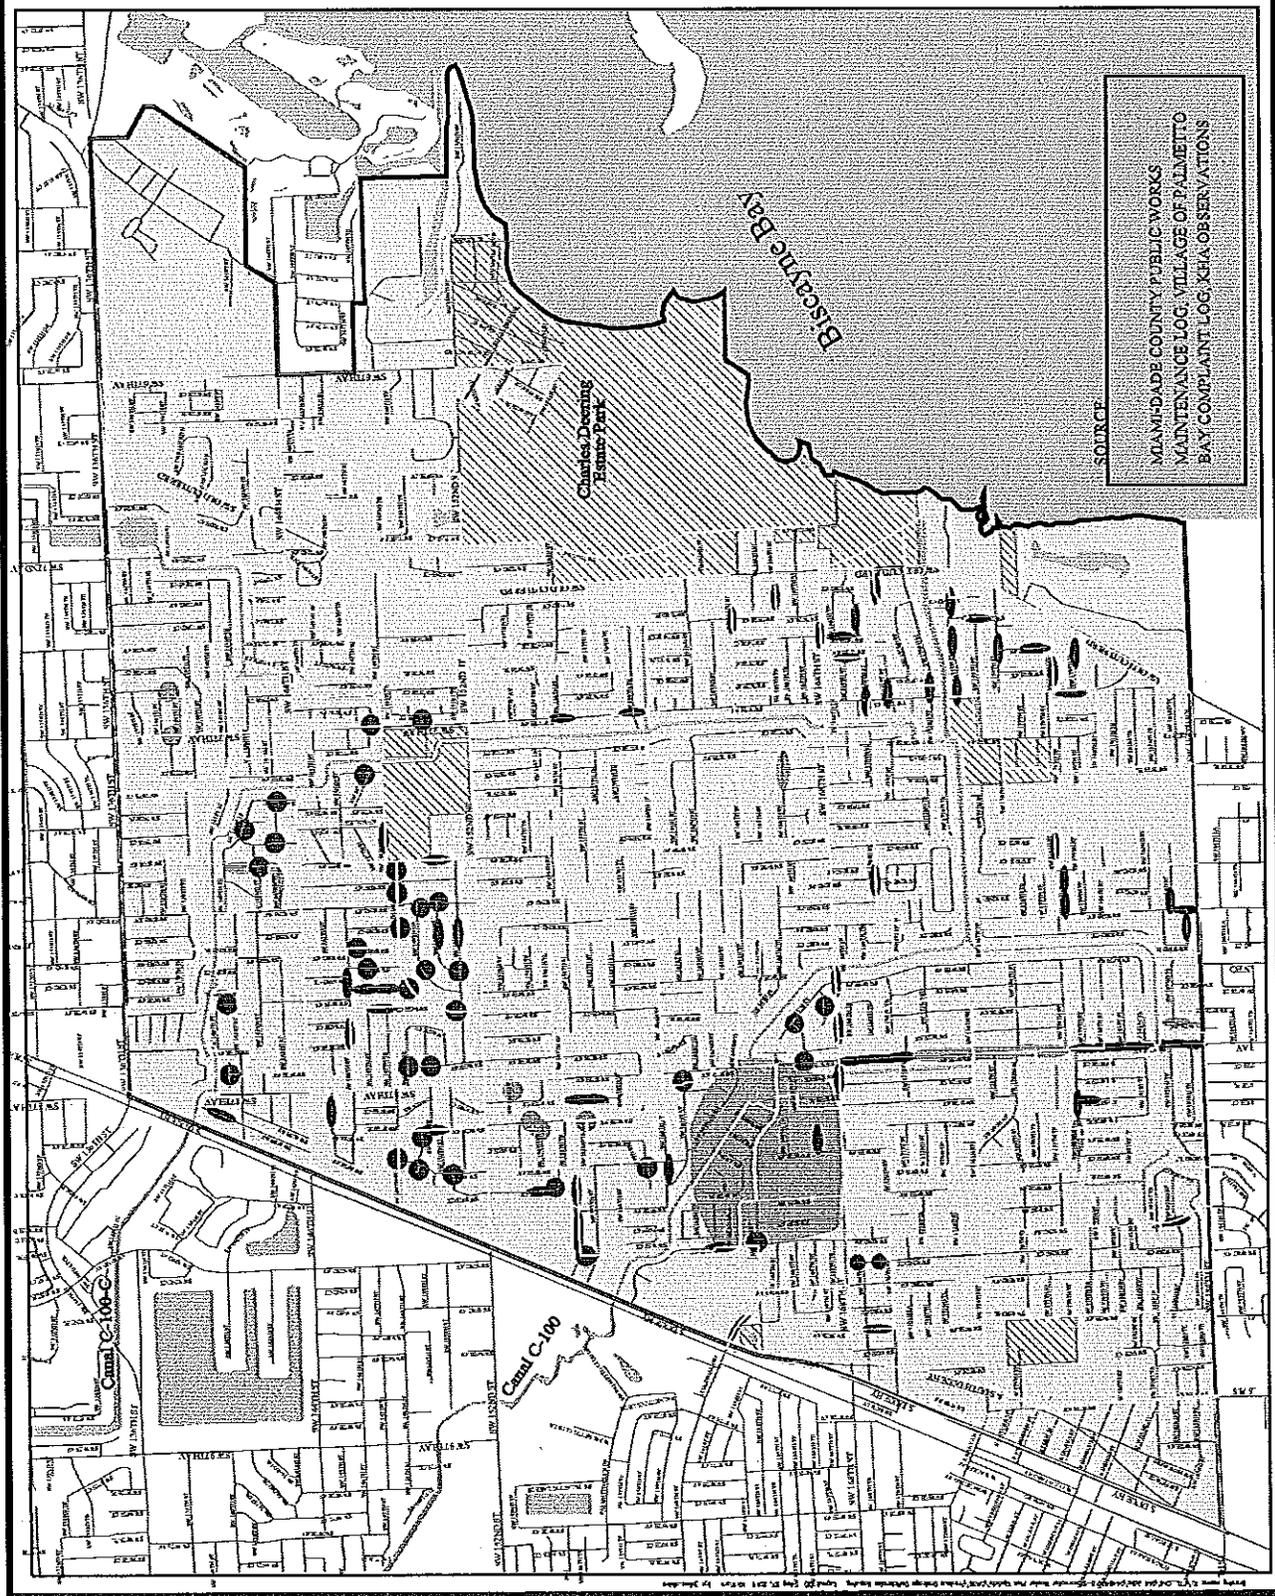
**Figure 2:  
Village of Palmetto Bay  
Drainage Deficiencies  
Original 2004 Plan**

Figure 2 shows the location of stormwater problem areas identified in the original Stormwater Master Plan. The various types of drainage and flood related complaints or observations were identified with color coded dots.

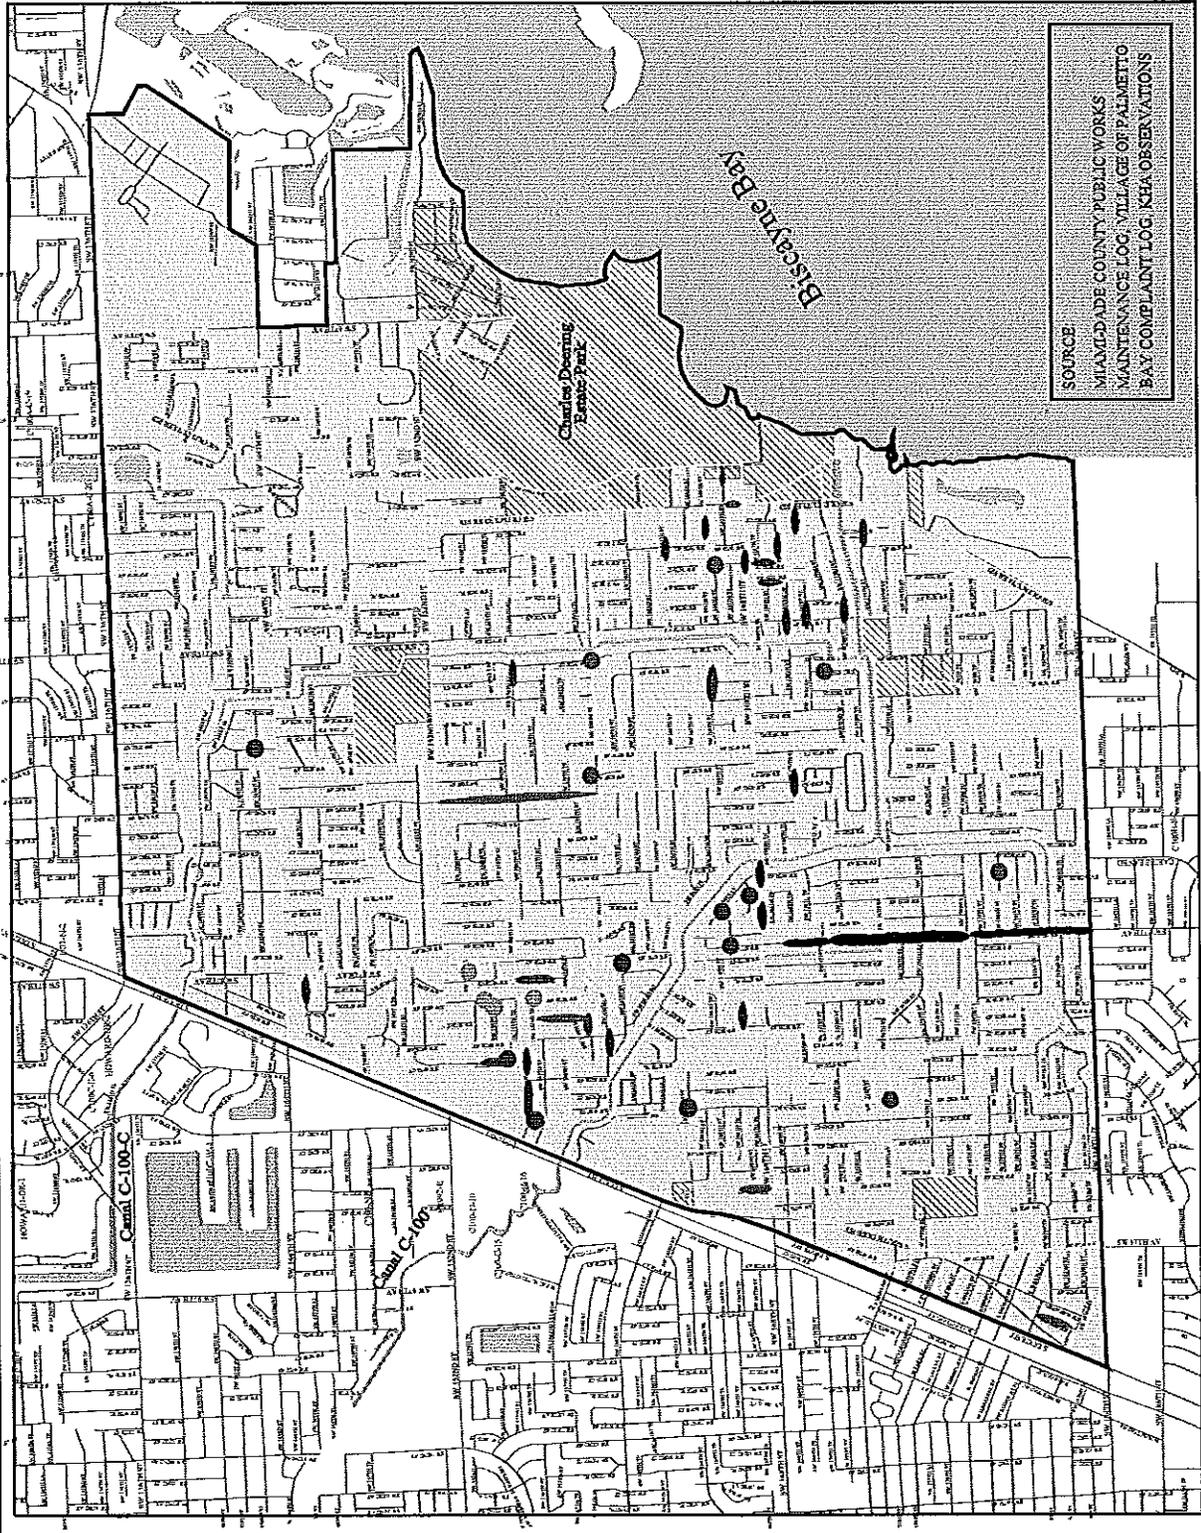
**Figure 4:**  
**Village of Palmetto Bay**  
**Drainage Deficiencies**  
**Updated 2014 Plan**

Figure 4 illustrates the updated drainage deficiency map. Based on sub-basin area, Figure 4 as compared to Figure 2 reflects that approximately 60% of the drainage deficiencies identified in the original Stormwater Master Plan have been addressed by the Village.

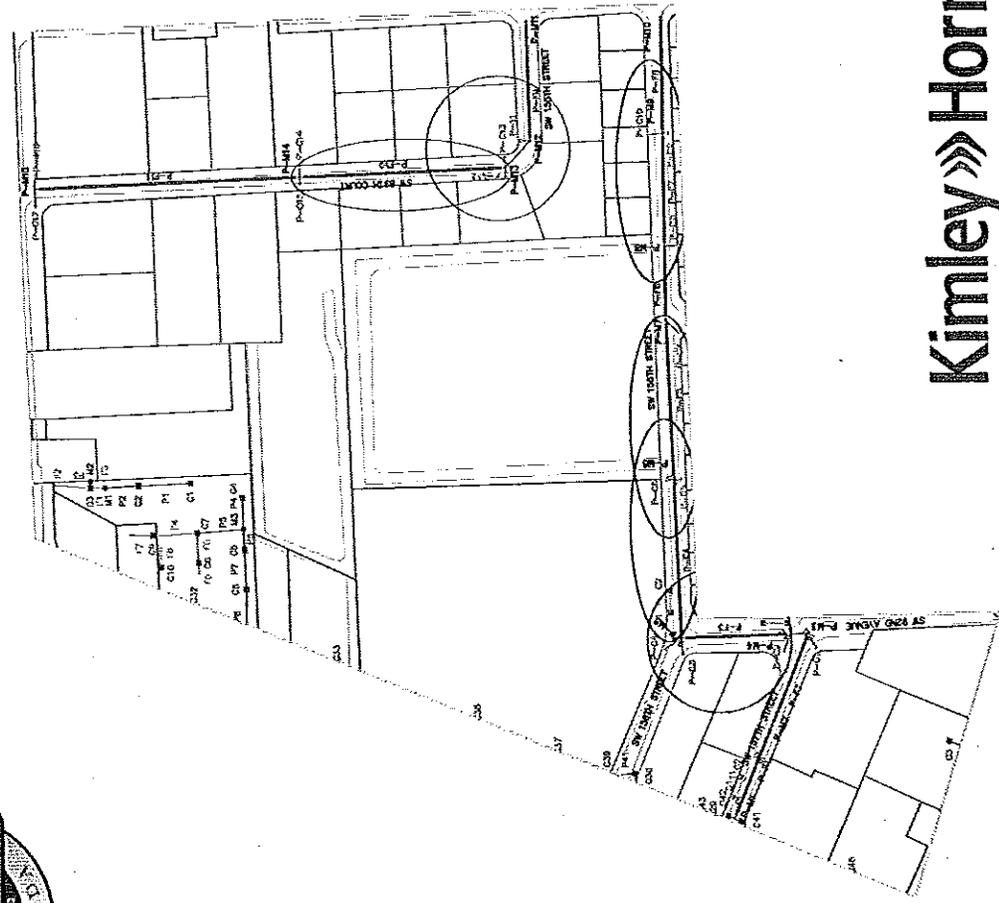
**FIGURE 6:  
DRAINAGE SUB-BASIN #11  
PROPOSED CONDITIONS**

**Existing and Future Conditions:** Figure 6 shows existing conditions for drainage sub-basin 11. The sub-basin consists of approximately 48.37 acres of existing residential and commercial development with approximately 6,470 linear feet of roadway, including SW 92nd Avenue, SW 89th Court, SW 89th Avenue, SW 157th Street, SW 156th Street, and SW 155th Street. The drainage system in this sub-basin is a closed system with catch basins connected to exfiltration trench located in the vegetated swales along the sides of the roadways.

**Storm Drainage Deficiencies:** The catch basins inspected in this sub-basin were observed to be clean, with only limited debris and sediment. As a result, drainage deficiency issues are likely to be a function of limited system capacity and infrastructure age and or condition. Hydrologic and hydraulic calculations for this sub-basin confirmed the existing drainage infrastructure does not discharge adequate runoff to meet the desired performance criteria. The capacity of the existing swales and French drains is not sufficient to discharge the volume of runoff outlined in the performance criteria during the modeled storm events. Pavement condition within the sub-basin area is generally average and in need of resurfacing or rehabilitation. Improvements to drainage infrastructure will be needed to address these inadequacies.

**Recommended Drainage Improvements:** Clean and flush all sediment and debris from existing catch basins and pipes and adjust catch basin elevations and locations to minimize accumulation of sediment and debris. Install the additional infrastructure depicted in Figure 6. Existing catch basins should be modified or reconstructed as required to provide sediment traps (sumps) and pollution retardant baffles to protect the exfiltration trench. Constructing additional catch basins, manholes, culverts, and exfiltration trench is recommended to interconnect the catch basins.

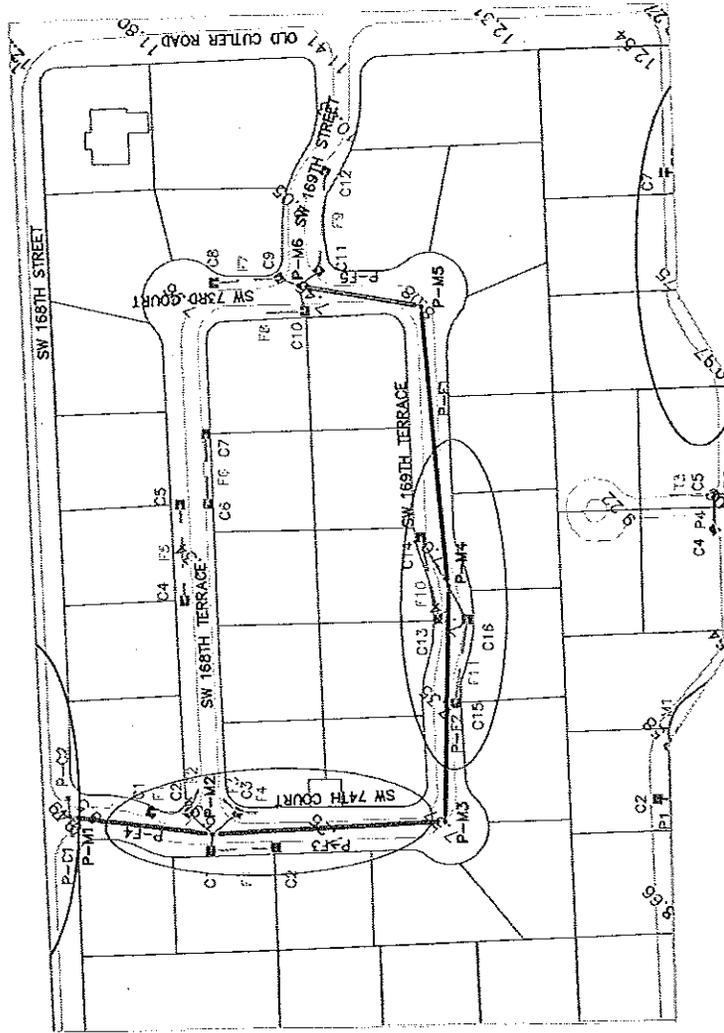
## FIGURE 7: DRAINAGE SUB-BASIN #12 PROPOSED CONDITIONS

**Existing and Future Conditions:** Figure 7 shows existing conditions for Drainage sub-basin 12. The sub-basin consists of approximately 25.26 acres of existing detached single-family residential development with approximately 2,290 linear feet of roadway, including SW 76th Avenue, SW 74th Court, SW 168th Terrace, SW 169th Terrace, SW 73rd Court, and SW 169th Street. The drainage system in this sub-basin is a closed system with catch basins connected to exfiltration trench located in the vegetated swales along the sides of the roadways.

No complaints were reported in this area by the Village, but complaints from Miami-Dade County were identified as part of the original master plan. In our investigation, Kimley-Horn found flooding extending across the entire roadway width on SW 169th Terrace, SW 75th Avenue, and SW 74th Court. The location of these deficiencies can be seen in Figure 7. The entire sub-basin area was modeled based on data collected as part of the Stormwater Master Plan process.

**Storm Drainage Deficiencies:** The catch basins inspected in this sub-basin were observed to be clean, with only limited debris and sediment. As a result, drainage deficiency issues are likely to be a function of limited system capacity and infrastructure age and or condition. Hydrologic and hydraulic calculations for this sub-basin confirmed the existing drainage infrastructure does not discharge adequate runoff to meet the desired performance criteria. The capacity of the existing swales and French drains is not sufficient to discharge the volume of runoff outlined in the performance criteria during the modeled storm events. Pavement condition within the sub-basin area is generally in good condition, but would benefit from resurfacing. Improvements to drainage infrastructure will be needed to address these inadequacies.

**Recommended Drainage Improvements:** Clean and flush all sediment and debris from existing catch basins and pipes and adjust catch basin elevations and locations to minimize accumulation of sediment and debris. Install the additional infrastructure depicted in Figure 7. Existing catch basins should be modified or reconstructed as required to provide sediment traps (sumps) and pollution retardant baffles to protect the exfiltration trench. Constructing additional catch basins, manholes, culverts, and exfiltration trench is recommended to interconnect the catch basins.
