**RESOLUTION NO. 2015-19**

**A RESOLUTION OF THE MAYOR AND VILLAGE COUNCIL OF THE VILLAGE OF PALMETTO BAY, FLORIDA; RELATING TO THE STORMWATER MASTER PLAN UPDATE REPORT, ACCEPTING THE FINAL REPORT DOCUMENTS AND RECOMMENDATIONS; FURTHER AUTHORIZING THE VILLAGE MANAGER TO PROCEED WITH IMPLEMENTATION OF THE REPORT FINDINGS, FOLLOWING IDENTIFICATION AND AVAILABILITY OF APPROPRIATE FUNDING SOURCES; AND PROVIDING FOR AN EFFECTIVE DATE.**

Prepared For  
Village of Palmetto Bay, Florida

# Stormwater Master Plan Update

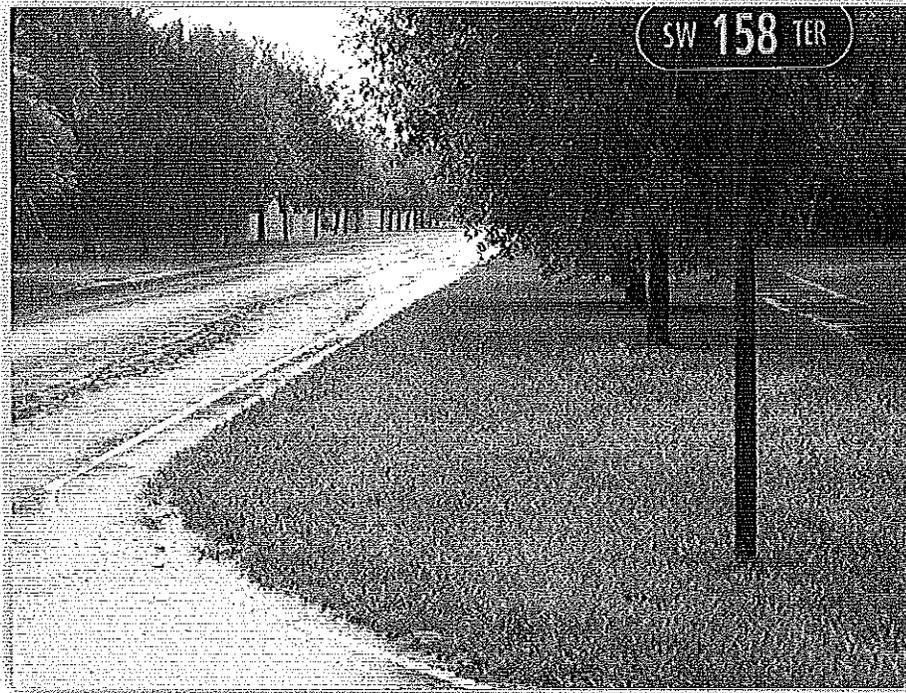
**Figure 4:**  
**Village of Palmetto Bay**  
**Drainage Deficiencies**  
**Updated 2014 Plan**

Figure 4 illustrates the updated drainage deficiency map. Based on sub-basin area, Figure 4 as compared to Figure 2 reflects that approximately 60% of the drainage deficiencies identified in the original Stormwater Master Plan have been addressed by the Village.

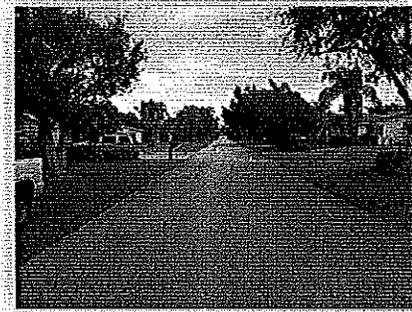
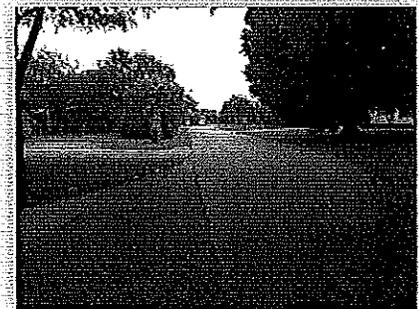
No complaints were reported in this area by the Village as part of this update or from Miami-Dade County as part of the original master plan. In our investigation, Kimley-Horn found flooding extending across the entire roadway width on SW 156th Street, SW 92nd Avenue, SW 89th Court, and SW 155th Street. The location of these deficiencies can be seen in Figure 6. The entire sub-basin area was modeled based on data collected as part of the Stormwater Master Plan process.

**Recommended Drainage Improvements:** Clean and flush all sediment and debris from existing catch basins and pipes and adjust catch basin elevations and locations to minimize accumulation of sediment and debris. Install the additional infrastructure depicted in Figure 6. Existing catch basins should be modified or reconstructed as required to provide sediment traps (sumps) and pollution retardant baffles to protect the exfiltration trench. Constructing additional catch basins, manholes, culverts, and exfiltration trench is recommended to interconnect the catch basins.

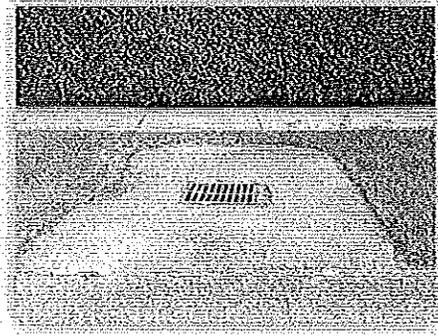
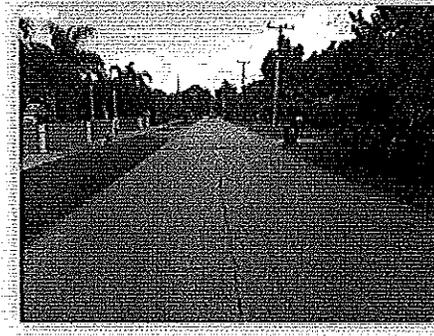
**Storm Drainage Deficiencies:** The catch basins inspected in this sub-basin were observed to be clean, with only limited debris and sediment. As a result, drainage deficiency issues are likely to be a function of limited system capacity and infrastructure age and or condition. Hydrologic and hydraulic calculations for this sub-basin confirmed the existing drainage infrastructure does not discharge adequate runoff to meet the desired performance criteria. The capacity of the existing swales and French drains is not sufficient to discharge the volume of runoff outlined in the performance criteria during the modeled storm events. Pavement condition within the sub-basin area is generally average and in need of resurfacing or rehabilitation. Improvements to drainage infrastructure will be needed to address these inadequacies.

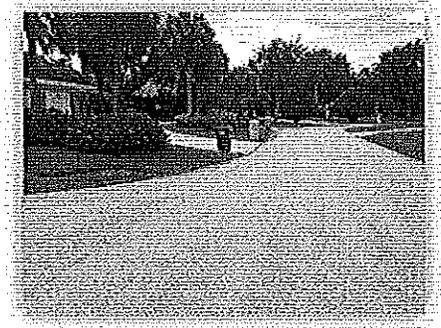
No complaints were reported in this area by the Village, but complaints from Miami-Dade County were identified as part of the original master plan. In our investigation, Kimley-Horn found flooding extending across the entire roadway width on SW 169th Terrace, SW 75th Avenue, and SW 74th Court. The location of these deficiencies can be seen in Figure 7. The entire sub-basin area was modeled based on data collected as part of the Stormwater Master Plan process.

**Recommended Drainage Improvements:** Clean and flush all sediment and debris from existing catch basins and pipes and adjust catch basin elevations and locations to minimize accumulation of sediment and debris. Install the additional infrastructure depicted in Figure 7. Existing catch basins should be modified or reconstructed as required to provide sediment traps (sumps) and pollution retardant baffles to protect the exfiltration trench. Constructing additional catch basins, manholes, culverts, and exfiltration trench is recommended to interconnect the catch basins.

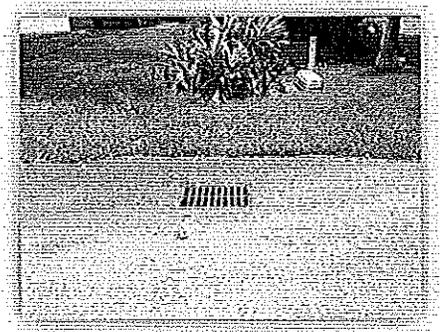
No complaints were reported in this area by the Village as part of this update or from Miami-Dade County as part of the original master plan. In our investigation, Kimley-Horn found flooding extending across the entire roadway width on SW 171st Street and SW 77th Avenue. The location of these deficiencies can be seen in Figure 8. The entire sub-basin area was modeled based on data collected as part of the Stormwater Master Plan process.

**Recommended Drainage Improvements:** Clean and flush all sediment and debris from existing catch basins and pipes and adjust catch basin elevations and locations to minimize accumulation of sediment and debris. Install the additional infrastructure depicted in Figure 8. Existing catch basins should be modified or reconstructed as required to provide sediment traps (sumps) and pollution retardant baffles to protect the exfiltration trench. Constructing additional catch basins, manholes, culverts, and exfiltration trench is recommended to interconnect the catch basins. This sub-basin has the possibility of a new outfall connection as well.

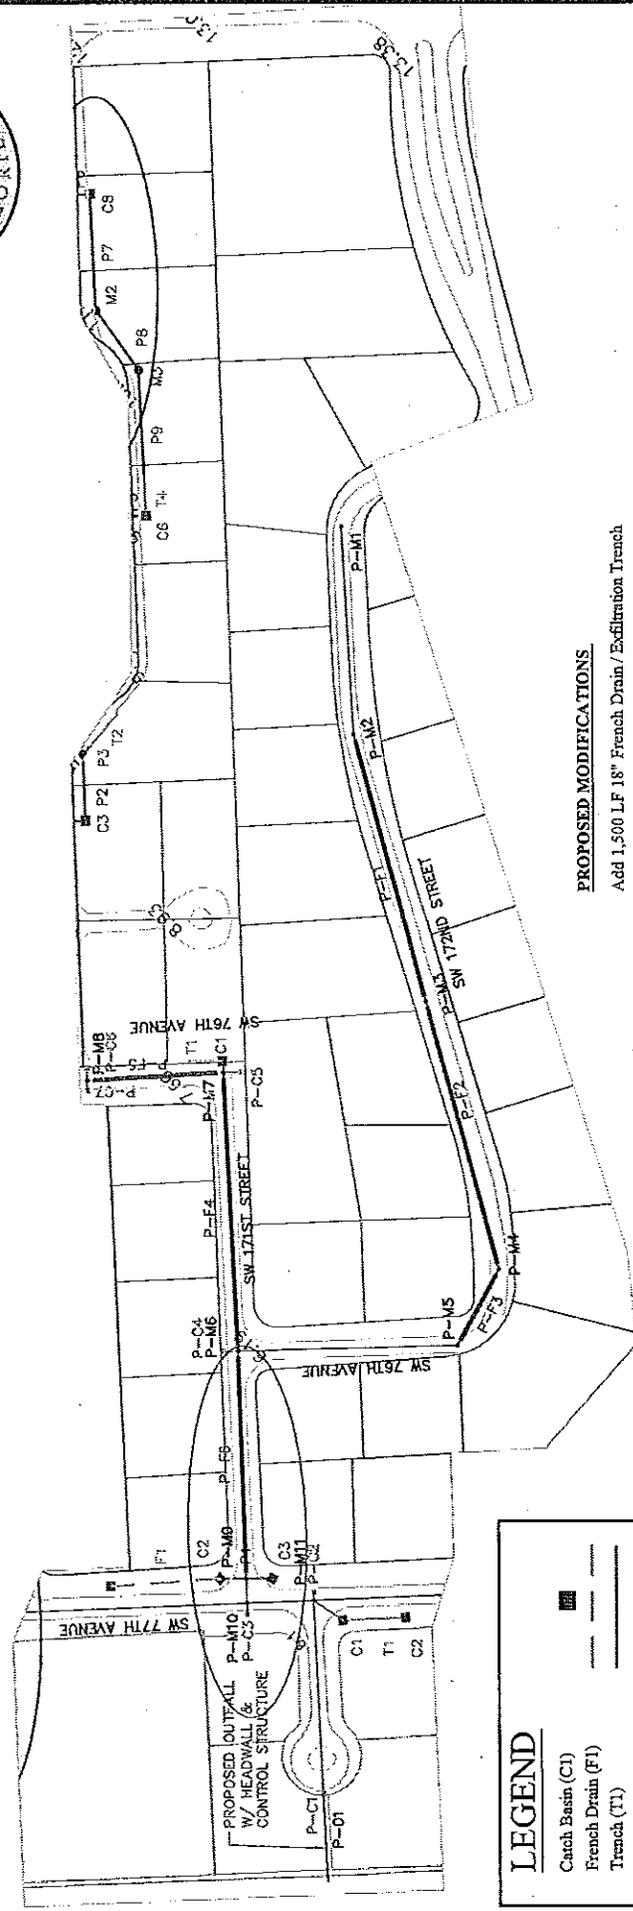
# FIGURE 8: DRAINAGE SUB-BASIN #39 PROPOSED CONDITIONS

**Existing and Future Conditions:** Figure 8 shows existing conditions for drainage sub-basin 39. The sub-basin consists of approximately 21.22 acres of existing detached single-family residential development with approximately 3,260 linear feet of roadway, including SW 172nd Street, SW 171st Street, SW 171st Terrace, SW 77th Avenue (Palmetto Road), SW 76th Avenue, and SW 74th Avenue. The drainage system in this sub-basin is a closed system with catch basins connected to exfiltration trench located in the vegetated swales along the sides of the roadways.

**Storm Drainage Deficiencies:** The catch basins inspected in this sub-basin were observed to be clean, with only limited debris and sediment. As a result, drainage deficiency issues are likely to be a function of limited system capacity and infrastructure age and or condition. Hydrologic and hydraulic calculations for this sub-basin confirmed the existing drainage infrastructure does not discharge adequate runoff to meet the desired performance criteria. The capacity of the existing swales and French drains is not sufficient to discharge the volume of runoff outlined in the performance criteria during the modeled storm events. Pavement condition within the sub-basin area is generally in good condition, but would benefit from resurfacing. Roadway settlement at the intersection of SW 171st Street and SW 77th Avenue was observed. Improvements to drainage infrastructure will be needed to address these inadequacies. SW 171st Street is a cul-de-sac with an opportunity to install an outfall connection. No existing outfall was observed.

- Add 1,500 LF 18" French Drain / Exfiltration Trench
- Add 1,050 LF of 18" Storm Sewer Pipe (HDPE)
- Add 150 LF of 15" Storm Sewer Pipe (HDPE)
- Add 7 Catch Basins
- Add 11 Manholes
- Add 1 Headwall
- Add 1 Control Structure

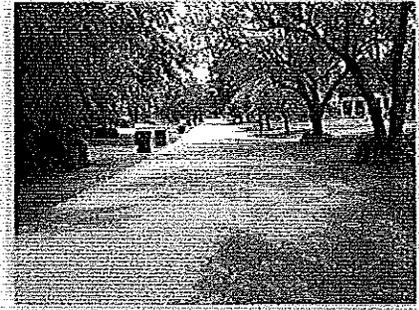
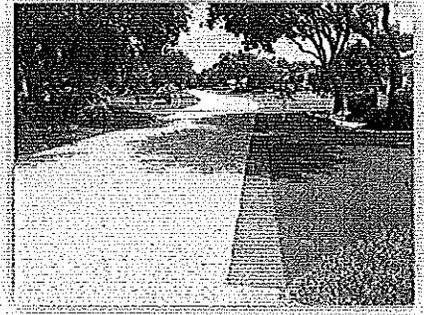
No complaints were reported in this area by the Village as part of this update or from Miami-Dade County as part of the original master plan. In our investigation, Kimley-Horn found flooding extending across the entire roadway width on SW 173rd Street, SW 174th Street, and SW 73rd Court. The location of these deficiencies can be seen in Figure 9.

The entire sub-basin area was modeled based on data collected as part of the Stormwater Master Plan process. The Village completed a local drainage repair on SW 174th Street just east of SW 77th Avenue (Palmetto Road).

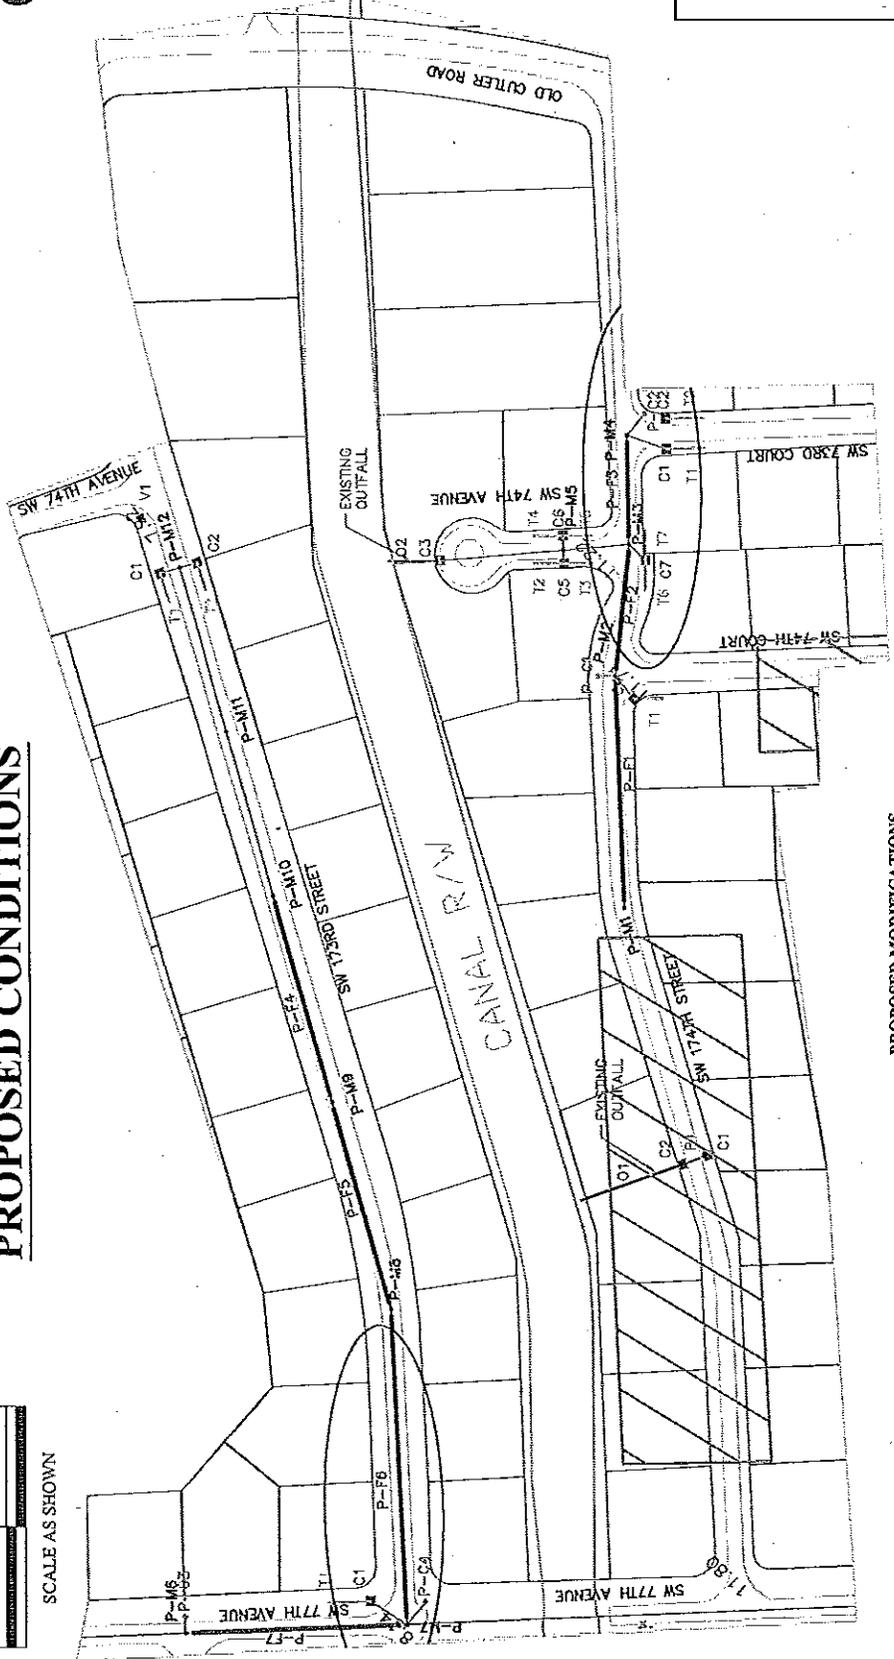
**FIGURE 9:  
DRAINAGE SUB-BASIN #41  
PROPOSED CONDITIONS**

**Storm Drainage Deficiencies:** The catch basins inspected in this sub-basin were observed to be clean, with only limited debris and sediment. As a result, drainage deficiency issues are likely to be a function of limited system capacity and infrastructure age and or condition. Hydrologic and hydraulic calculations for this sub-basin confirmed the existing drainage infrastructure does not discharge adequate runoff to meet the desired performance criteria. The capacity of the existing swales, outfalls, and French drains is not sufficient to discharge the volume of runoff outlined in the performance criteria during the modeled storm events. Pavement condition within the sub-basin area is generally in good condition, but would benefit from resurfacing. Improvements to drainage infrastructure will be needed to address these inadequacies. SW 77th Court is a cul-de-sac just west of the sub-basin 41 limits, but may provide an opportunity to install an outfall connection if needed. No existing outfall was observed.

**Recommended Drainage Improvements:** Clean and flush all sediment and debris from existing catch basins, pipes, outfalls, and adjust catch basin elevations and locations to minimize accumulation of sediment and debris. Install the additional infrastructure depicted in Figure 9. Existing catch basins should be modified or reconstructed as required to provide sediment traps (sumps) and pollution retardant baffles to protect the exfiltration trench. An analysis of the existing outfall capacities should be performed to evaluate the need for potential outfall improvements as well as the benefits of an additional outfall on SW 77th Court. Constructing additional catch basins, manholes, culverts, and exfiltration trench is recommended to interconnect the catch basins.

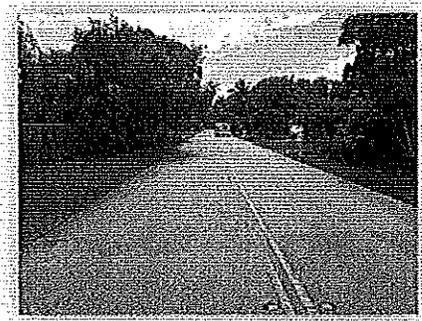
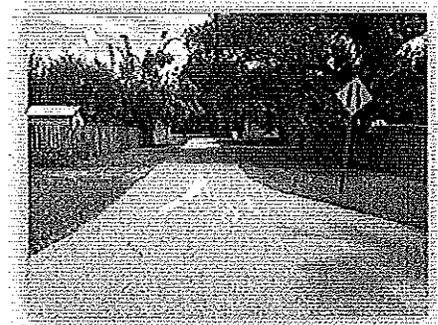
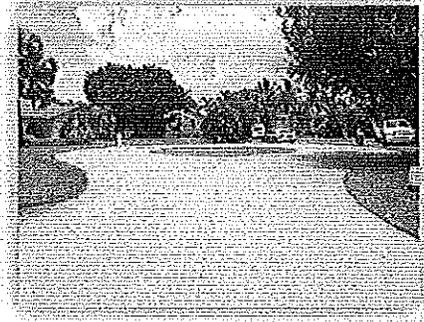
No complaints were reported in this area by the Village as part of this update or from Miami-Dade County as part of the original master plan. In our investigation, Kimley-Horn found flooding extending across the entire roadway width on SW 170th Street and SW 77th Avenue and on SW 169<sup>th</sup> Street and SW 76<sup>th</sup> Avenue. The location of these deficiencies can be seen in Figure 10. The entire sub-basin area was modeled based on data collected as part of the Stormwater Master Plan process.

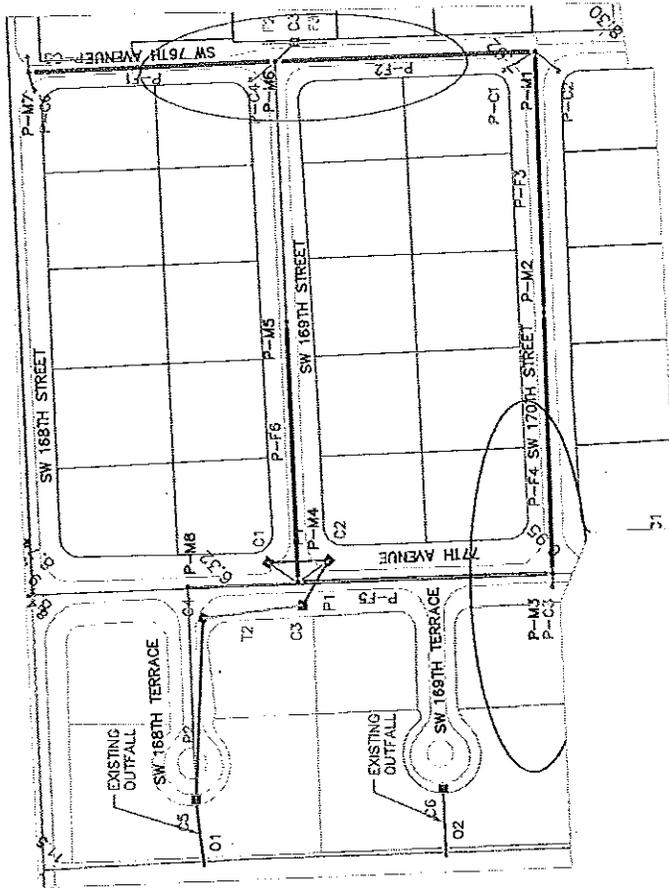
## FIGURE 10: DRAINAGE SUB-BASIN #42 PROPOSED CONDITIONS

**Storm Drainage Deficiencies:** The catch basins inspected in this sub-basin were observed to be clean, with only limited debris and sediment. As a result, drainage deficiency issues are likely to be a function of limited system capacity and infrastructure age and or condition. Hydrologic and hydraulic calculations for this sub-basin confirmed the existing drainage infrastructure does not discharge adequate runoff to meet the desired performance criteria. The capacity of the existing swales, outfalls, and French drains is not sufficient to discharge the volume of runoff outlined in the performance criteria during the modeled storm events. Pavement condition within the sub-basin area is generally average and in need of resurfacing or rehabilitation. Improvements to drainage infrastructure will be needed to address these inadequacies.

**Recommended Drainage Improvements:** Clean and flush all sediment and debris from existing catch basins, pipes, outfalls, and adjust catch basin elevations and locations to minimize accumulation of sediment and debris. Install the additional infrastructure depicted in Figure 10. Existing catch basins should be modified or reconstructed as required to provide sediment traps (sumps) and pollution retardant baffles to protect the exfiltration trench. An analysis of the existing outfall capacities should be performed to evaluate the need for potential outfall improvements. Constructing additional catch basins, manholes, culverts, and exfiltration trench is recommended to interconnect the catch basins.

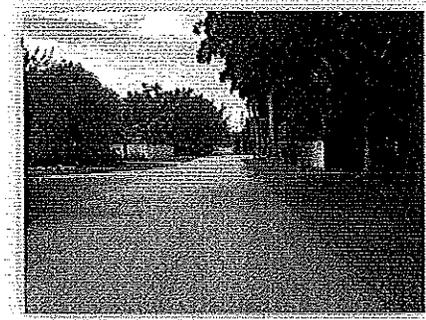
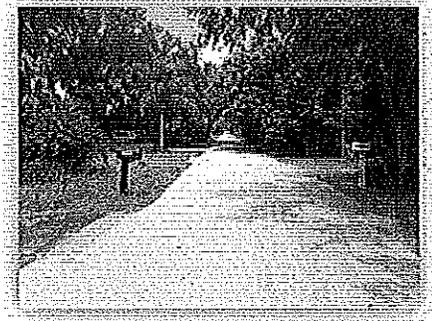
Complaints were reported in this area by the Village at SW 167<sup>th</sup> Street and on Old Cutler Road. Complaints from Miami-Dade County were identified in drainage sub-basin 43 as part of the original master plan. In our investigation, Kimley-Horn found flooding extending across the entire roadway width on SW 166th Street, SW 166<sup>th</sup> Terrace and

SW 74th Court. The location of these deficiencies can be seen in Figure 11. The entire sub-basin area was modeled based on data collected as part of the Stormwater Master Plan process.

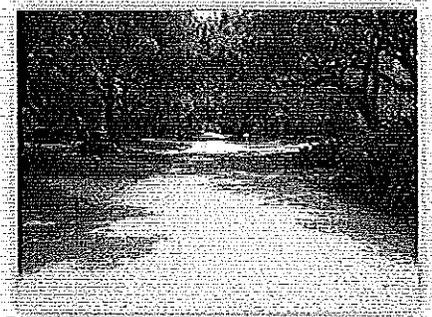
**Storm Drainage Deficiencies:** The catch basins inspected in this sub-basin were observed to be clean, with only limited debris and sediment. As a result, drainage deficiency issues are likely to be a function of limited system capacity and infrastructure age and or condition. Hydrologic and hydraulic calculations for this sub-basin confirmed the existing drainage infrastructure does not discharge adequate runoff to meet the desired performance criteria. The capacity of the existing swales and French drains is not sufficient to discharge the volume of runoff outlined in the performance criteria during the modeled storm events. Pavement condition within the sub-basin area is generally average and in need of resurfacing or rehabilitation. Improvements to drainage infrastructure will be needed to address these inadequacies.

**Recommended Drainage Improvements:** Clean and flush all sediment and debris from existing catch basins and pipes and adjust catch basin elevations and locations to minimize accumulation of sediment and debris. Install the additional infrastructure depicted in Figure 11. Existing catch basins should be modified or reconstructed as required to provide sediment traps (sumps) and pollution retardant baffles to protect the exfiltration trench. Constructing additional catch basins, manholes, culverts, and exfiltration trench is recommended to interconnect the catch basins.

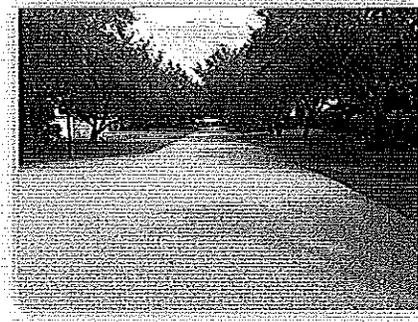
No complaints were reported in this area by the Village as part of this update or from Miami-Dade County as part of the original master plan. In our investigation, Kimley-Horn found flooding extending across the entire roadway width on SW 164th Street, and SW 74th Avenue. The location of these deficiencies can be seen in Figure 12. The entire sub-basin area was modeled based on data collected as part of the Stormwater Master Plan process.

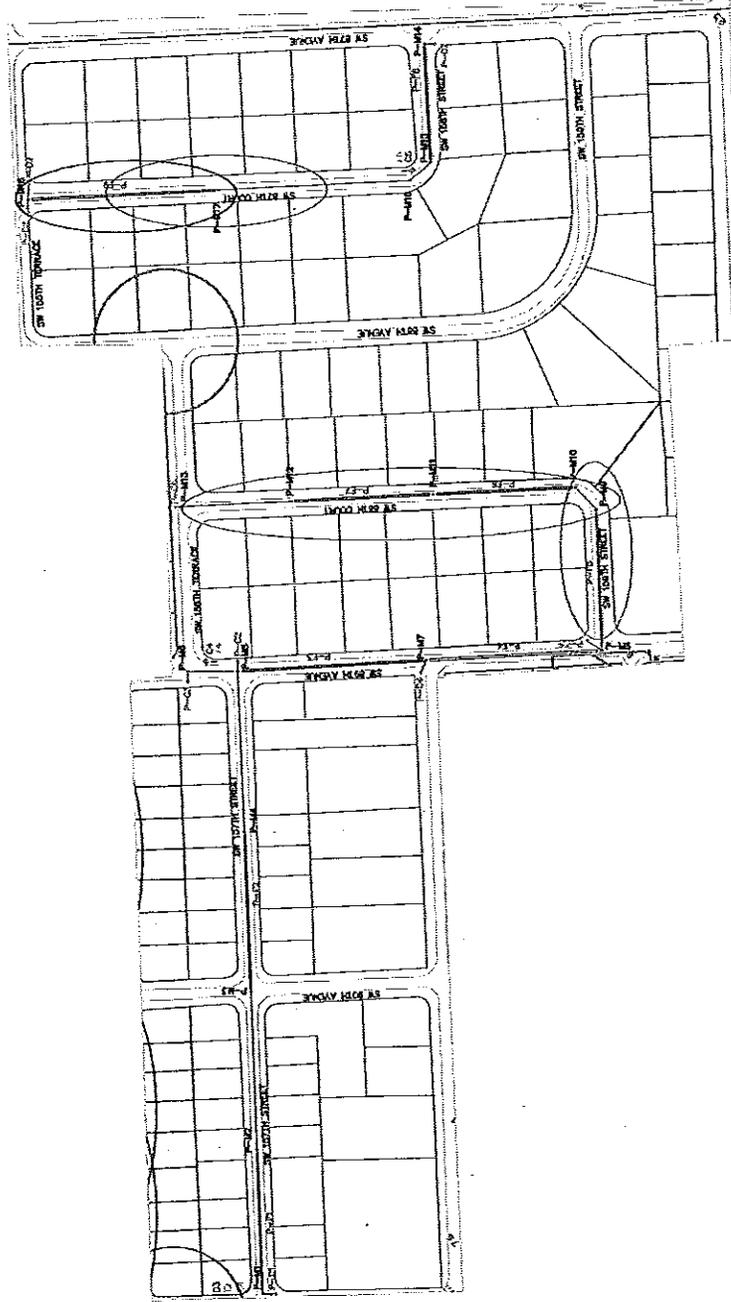
# FIGURE 13: DRAINAGE SUB-BASIN #57/96 PROPOSED CONDITIONS

The Village reported extensive flooding on SW 88th Court and SW 159th Street in drainage sub-basin 96. In our investigation, Kimley-Horn found flooding extending across the entire roadway width on SW 87th Court. The location of these deficiencies can be seen in Figure 13. The entire sub-basin area was modeled based on data collected as part of the Stormwater Master Plan process. The Village has a localized flooding project proposed at the intersection of SW 88th Avenue and SW 156th Terrace.

**Storm Drainage Deficiencies:** The catch basins inspected in this sub-basin were observed to be clean, with only limited debris and sediment. As a result, drainage deficiency issues are likely to be a function of limited system capacity and infrastructure age and or condition. Hydrologic and hydraulic calculations for this sub-basin confirmed the existing drainage infrastructure does not discharge adequate runoff to meet the desired performance criteria. The capacity of the existing swales and French drains is not sufficient to discharge the volume of runoff outlined in the performance criteria during the modeled storm events. SW 88th Avenue and SW 159th Street have recently been paved, but pavement condition within the remaining portions of the sub-basin area is generally average and in need of resurfacing or rehabilitation. Improvements to drainage infrastructure will be needed to address these inadequacies.

**Recommended Drainage Improvements:** Clean and flush all sediment and debris from existing catch basins and pipes and adjust catch basin elevations and locations to minimize accumulation of sediment and debris. Install the additional infrastructure depicted in Figure 13. Existing catch basins should be modified or reconstructed as required to provide sediment traps (sumps) and pollution retardant baffles to protect the exfiltration trench. Constructing additional catch basins, manholes, culverts, and exfiltration trench is recommended to interconnect the catch basins.

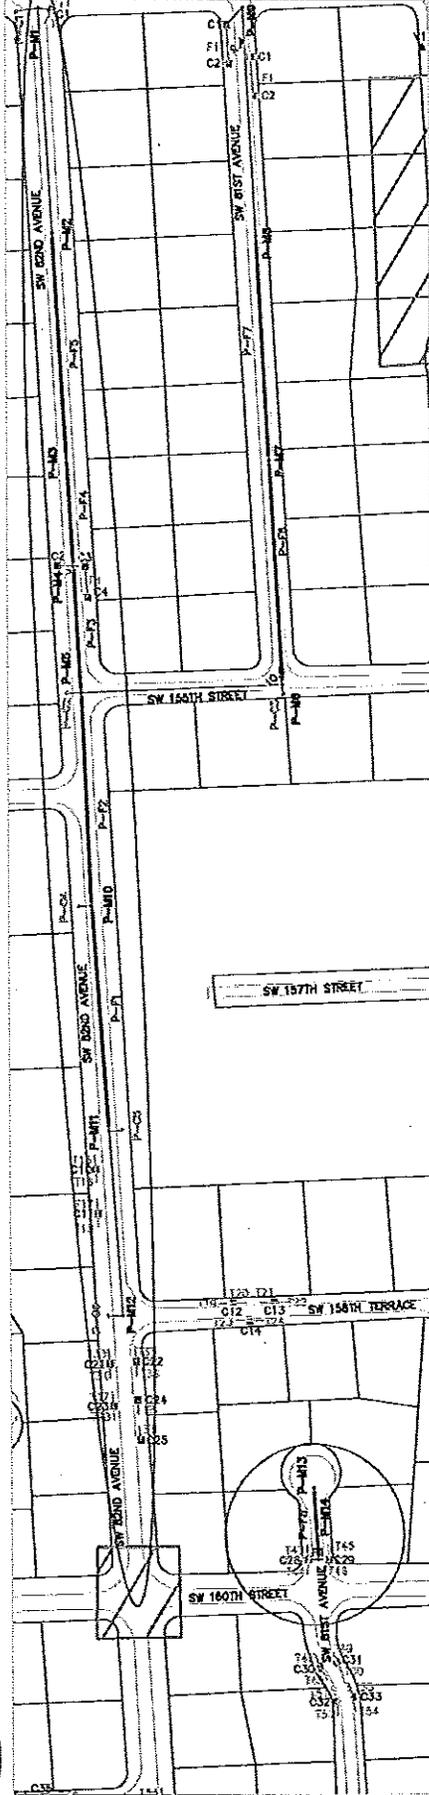
**FIGURE 14:  
DRAINAGE SUB-BASIN #59/60  
PROPOSED CONDITIONS**

The Village of Palmetto Bay reported severe flooding complaints on SW 82nd Avenue and localized flooding on SW 160th Street west of SW 80th Avenue. The location of these deficiencies can be seen in Figure 14. The entire sub-basin area was modeled based on data collected as part of the Stormwater Master Plan process. The Village installed a traffic circle with localized drainage improvements at the intersection of SW 160th Street and SW 82nd Avenue, as well as a second localized drainage improvement on SW 80th Avenue just south of SW 152nd Street.

**Storm Drainage Deficiencies:** The catch basins inspected in this sub-basin were observed to be clean, with only limited debris and sediment. As a result, drainage deficiency issues are likely to be a function of limited system capacity and infrastructure age and or condition. Hydrologic and hydraulic calculations for this sub-basin confirmed the existing drainage

infrastructure does not discharge adequate runoff to meet the desired performance criteria. The capacity of the existing swales and French drains is not sufficient to discharge the volume of runoff outlined in the performance criteria during the modeled storm events. Pavement condition within the sub-basin area is generally average and in need of resurfacing or rehabilitation. Improvements to drainage infrastructure will be needed to address these inadequacies.

**Recommended Drainage Improvements:** Clean and flush all sediment and debris from existing catch basins and pipes and adjust catch basin elevations and locations to minimize accumulation of sediment and debris. Install the additional infrastructure depicted in Figure 14. Existing catch basins should be modified or reconstructed as required to provide sediment traps (sumps) and pollution retardant baffles to protect the exfiltration trench. Constructing additional catch basins, manholes, culverts, and exfiltration trench is recommended to interconnect the catch basins.

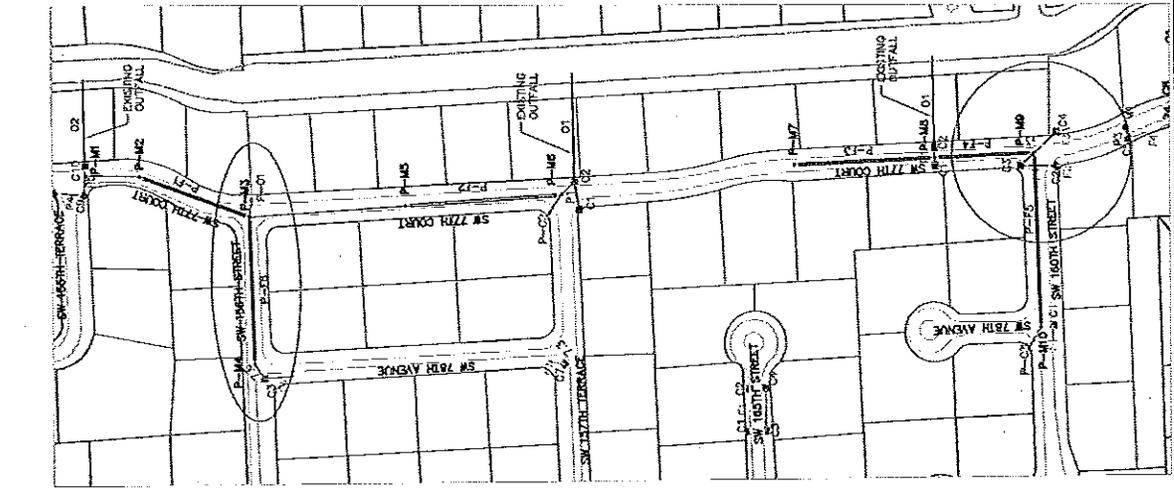
# FIGURE 15: DRAINAGE SUB-BASIN #61 PROPOSED CONDITIONS

The Village of Palmetto Bay reported flooding complaints on SW 156th Street, SW 160th Street, and SW 77th Court. The location of these deficiencies can be seen in Figure 15. The entire sub-basin area was modeled based on data collected as part of the Stormwater Master Plan process.

**Storm Drainage Deficiencies:** The catch basins inspected in this sub-basin were observed to be clean, with only limited debris and sediment. As a result, drainage deficiency issues are likely to be a function of limited system capacity and infrastructure age and or condition. Hydrologic and hydraulic calculations for this sub-basin confirmed the existing drainage infrastructure does not discharge adequate runoff to meet the desired performance criteria. The capacity of the existing swales, outfalls, and French drains is not sufficient to discharge the volume of runoff outlined in the performance criteria during the modeled storm events. Pavement condition within the sub-basin area is generally average and in need of resurfacing or rehabilitation. Improvements to drainage infrastructure will be needed to address these inadequacies. It is assumed that any speed humps impacted will require replacement as well.

**Recommended Drainage Improvements:** Clean and flush all sediment and debris from existing catch basins, pipes, outfalls, and adjust catch basin elevations and locations to minimize accumulation of sediment and debris. Install the additional infrastructure depicted in Figure 15. Existing catch basins should be modified or reconstructed as required to provide sediment traps (sumps) and pollution retardant baffles to protect the exfiltration trench. An analysis of the existing outfall capacities should be performed to evaluate the need for potential outfall improvements. Constructing additional catch basins, manholes, culverts, and exfiltration trench is recommended to interconnect the catch basins.
